ARCHITECTURAL CONDITIONS ASSESSMENT

December 31, 2016

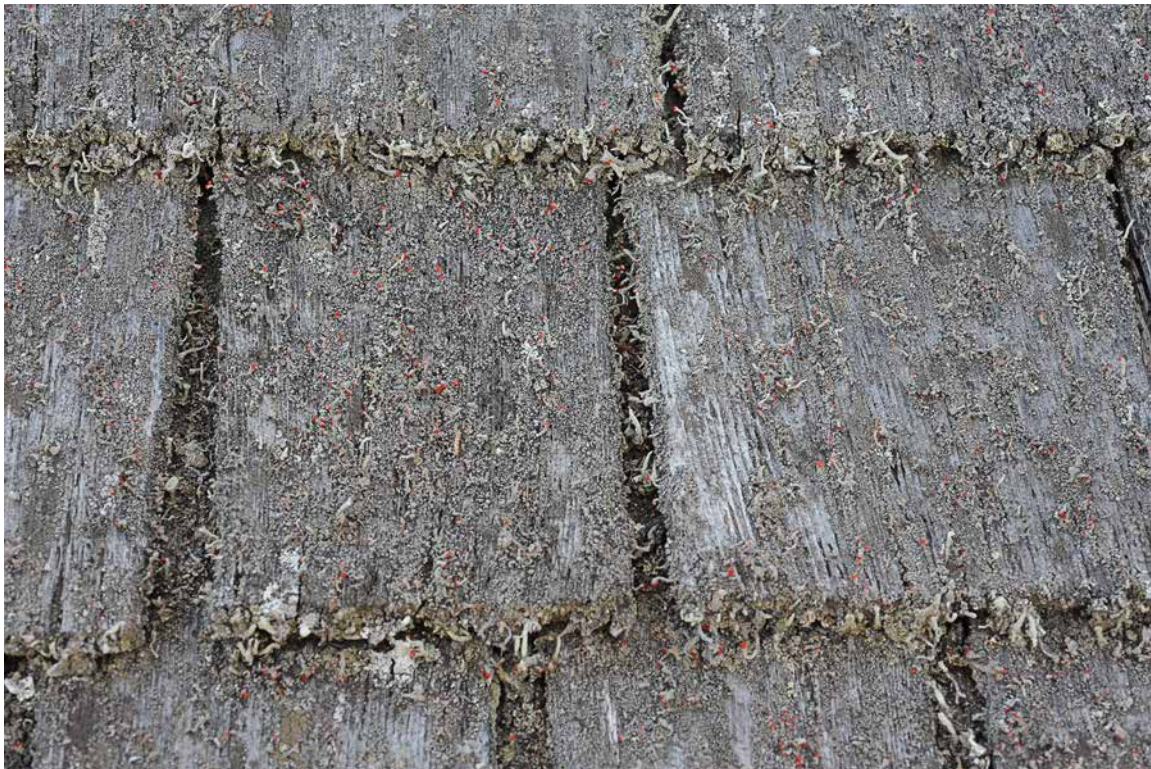
Photo 2: Detail of the front pitch shingles showing the lichen and numerous short splits in the shingles starting at the butts. Dampness is held on the roof by the lichen causing the shingles to rot at their butts.

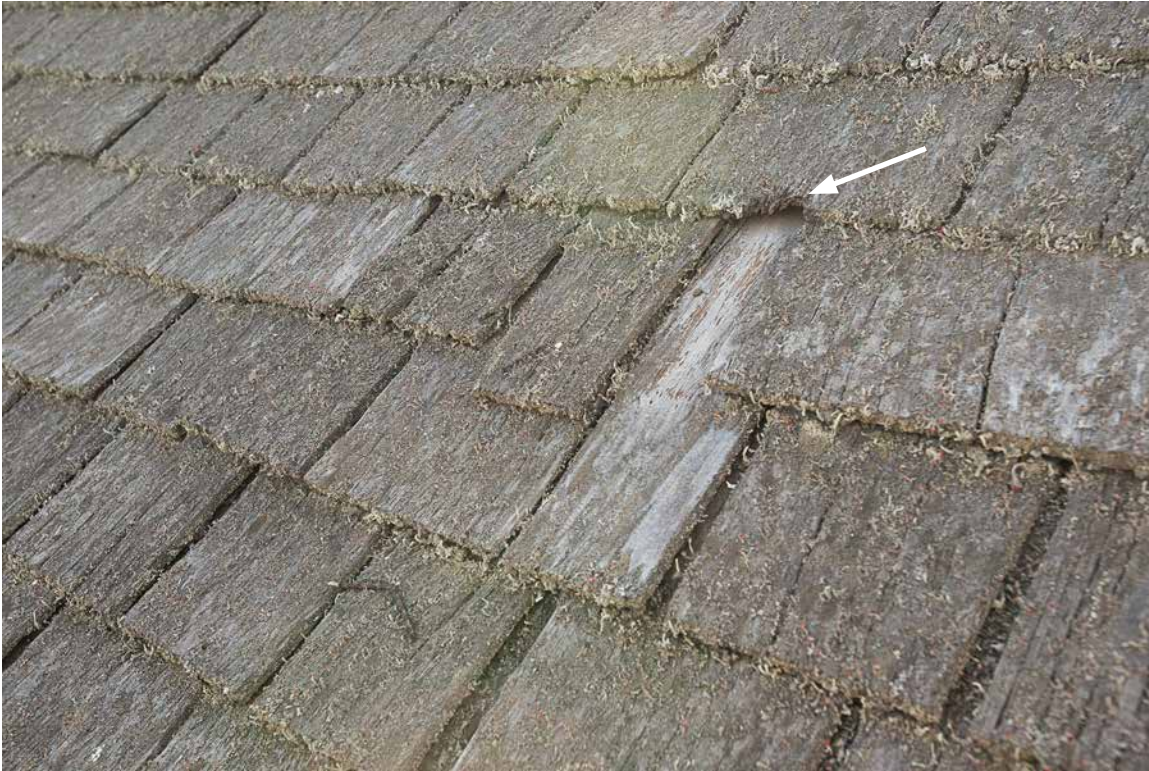
Photo 3: Detail of the front pitch shingles showing one shingle that has slipped off the roof and another slipping down. The arrow points to where the butt end of a shingle is disintegrating from rot. The shingles on this pitch are beyond their useful service life and should be replaced within the next 1-2 yeears.

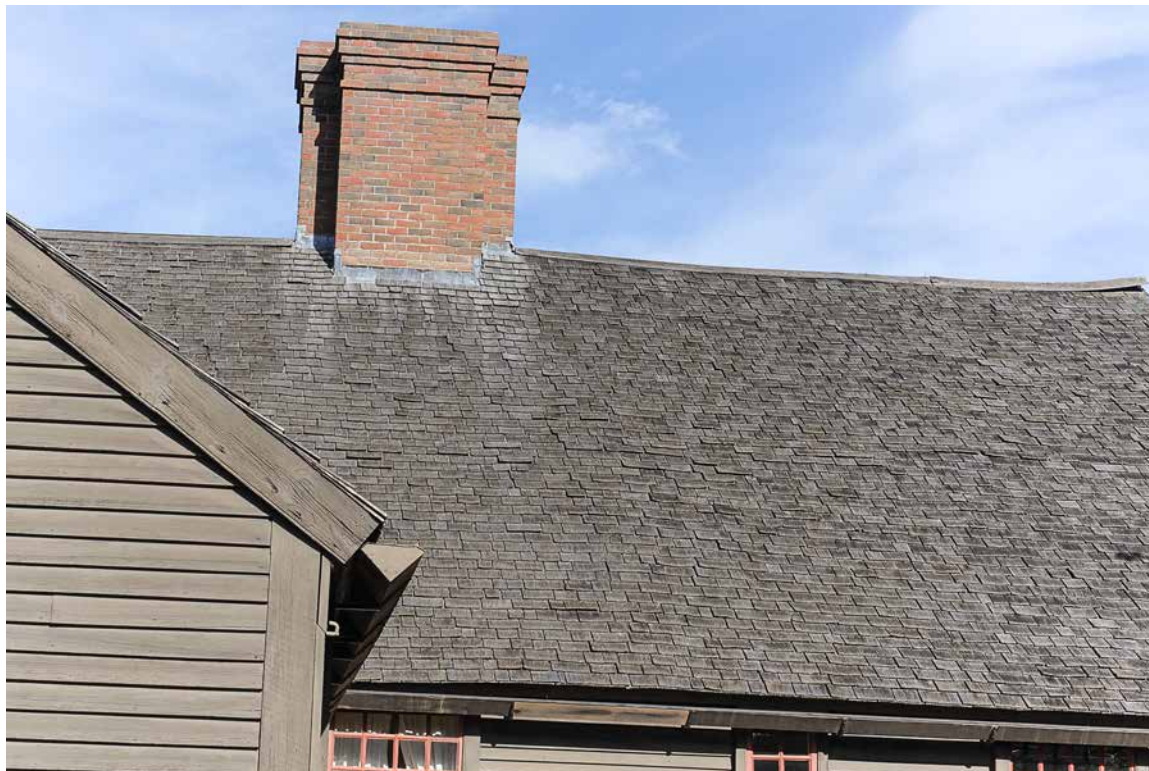
Photo 4: Overview of the rear (west) pitch of the main block roof. These shingles were installed in 1995 using stainless steel staples rather than nails. Some of the staples have come loose, but most are still holding.

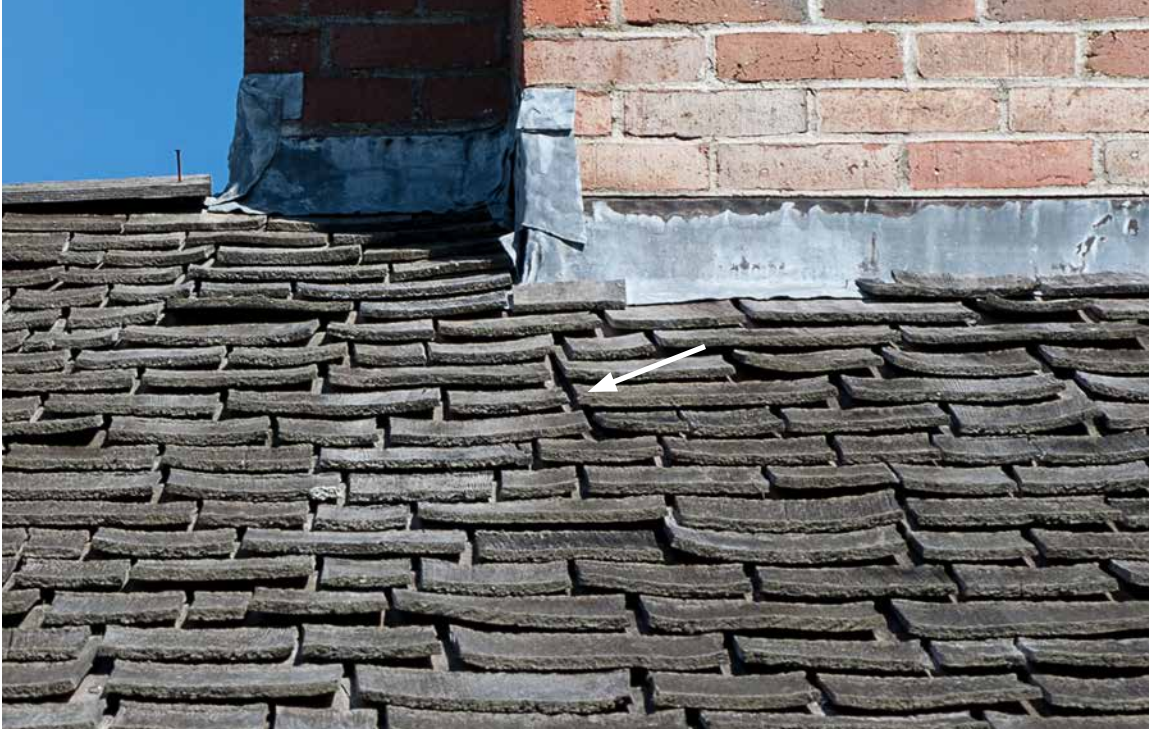
Photo 5: Detail of the rear pitch. Arrow points to one of several places on this pitch where the vertical joints between shingles are in alignment for three successive courses in violation of normal installation standards. Such alignment can generate roof leaks.

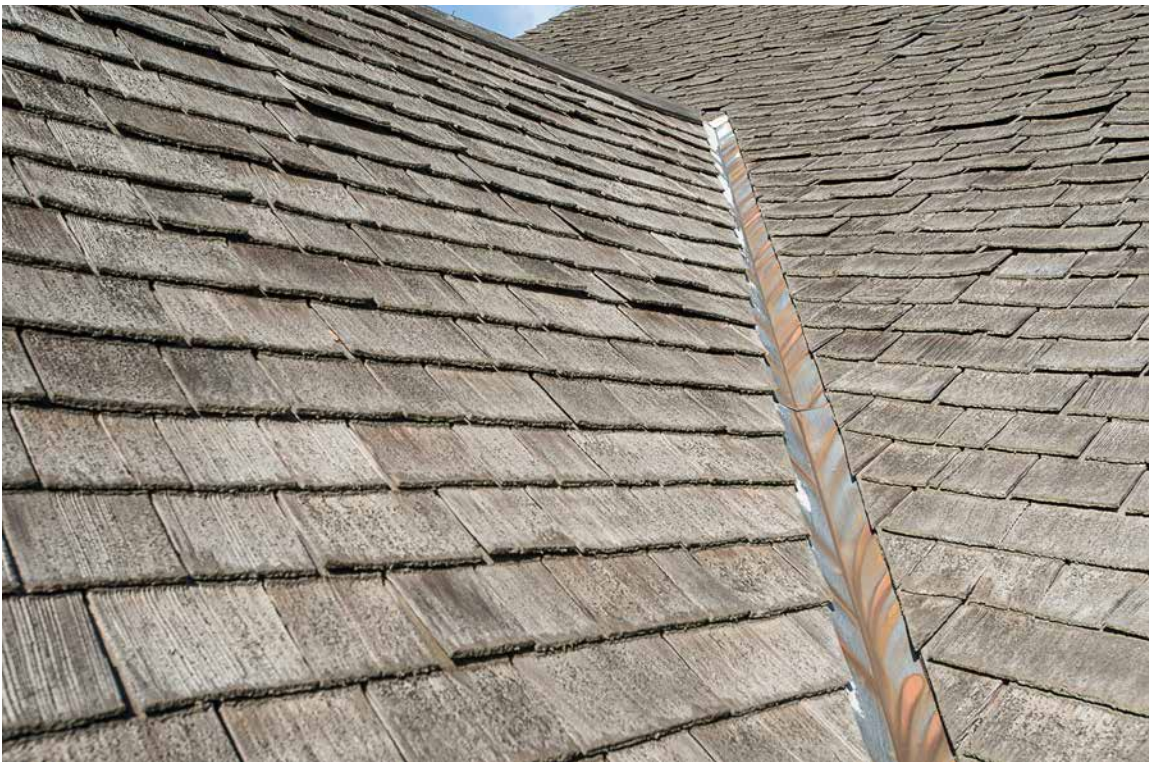
Photo 6: Copper valley between the rear main block pitch (right) and the rear ell south pitch (left). Leaks have been reported in the attic from the area to the right of the valley, but no obvious defects were observed in that area. The shingles on both of these pitches are fastened with stainless steel staples. The ell roof was installed at the same time as the rear main block roof in 1995.

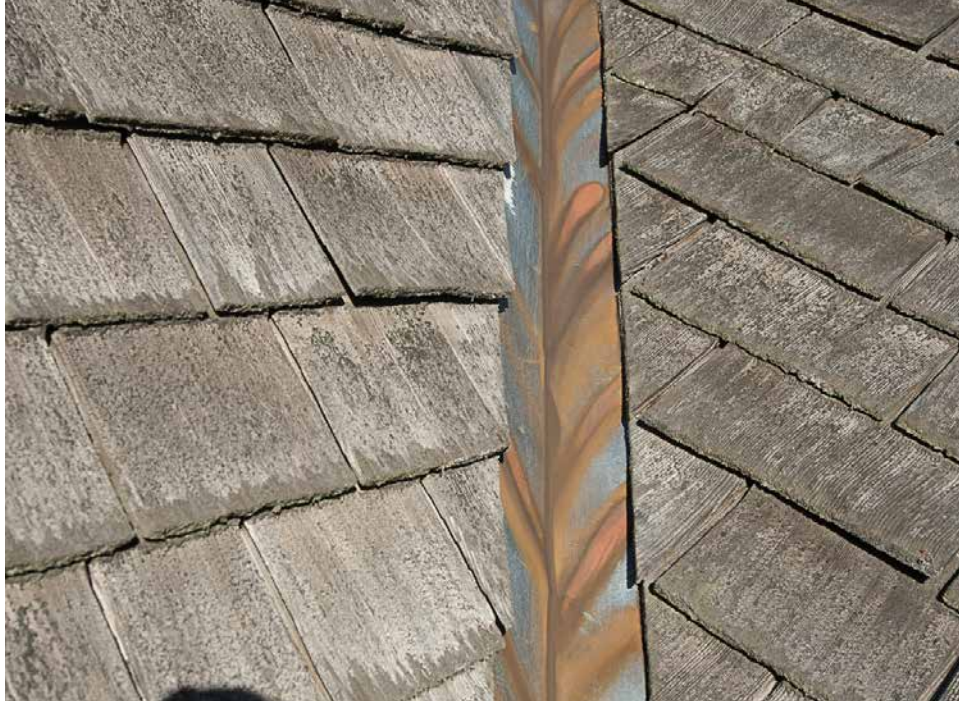
Photo 7: Detail of the copper valley in photo 6. The orange areas indicate wear to the copper from water running off the shingles, but there are no holes from the wear. Pushing on the copper at the wear spots indicated the wear is currently very minor.

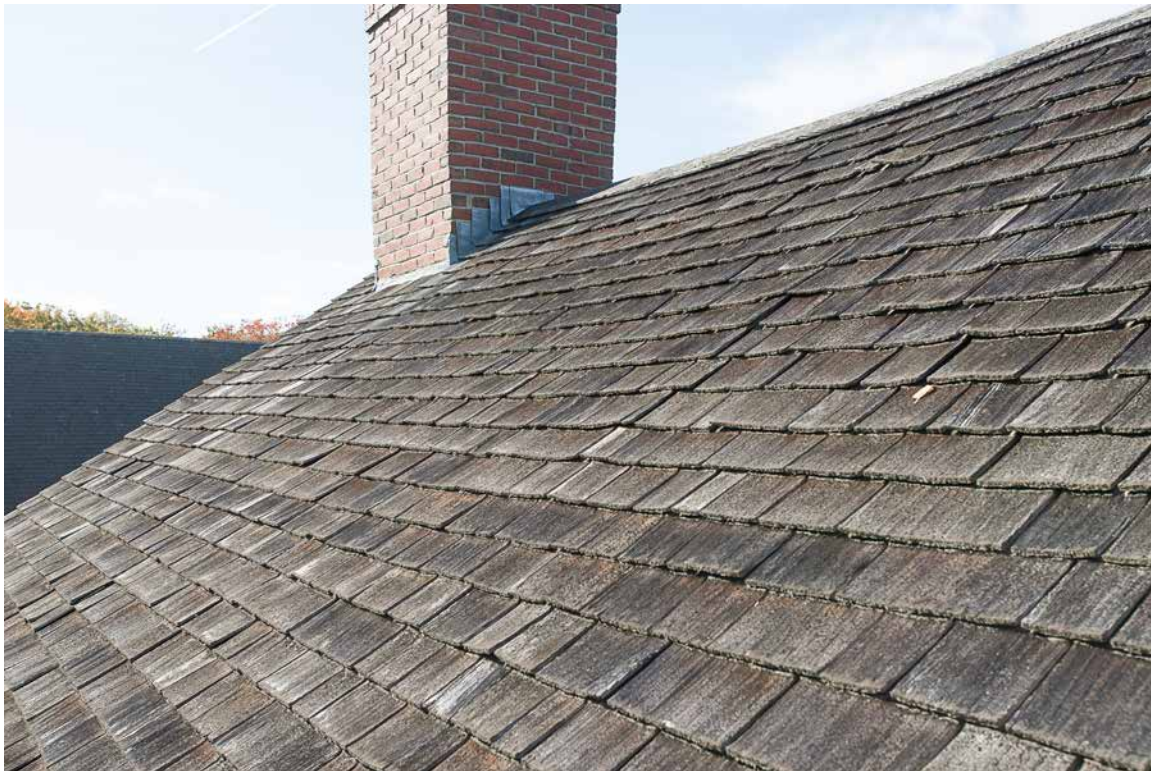
Photo 8: Overview of the south pitch of the rear ell roof and the ell chimney. From this vantage point the shingles appear to be sound, but when examined close up there is considerable wear to the surface of the shingles from ultra-violet (i.e, sun) exposure coupled with erosion from water runoff.

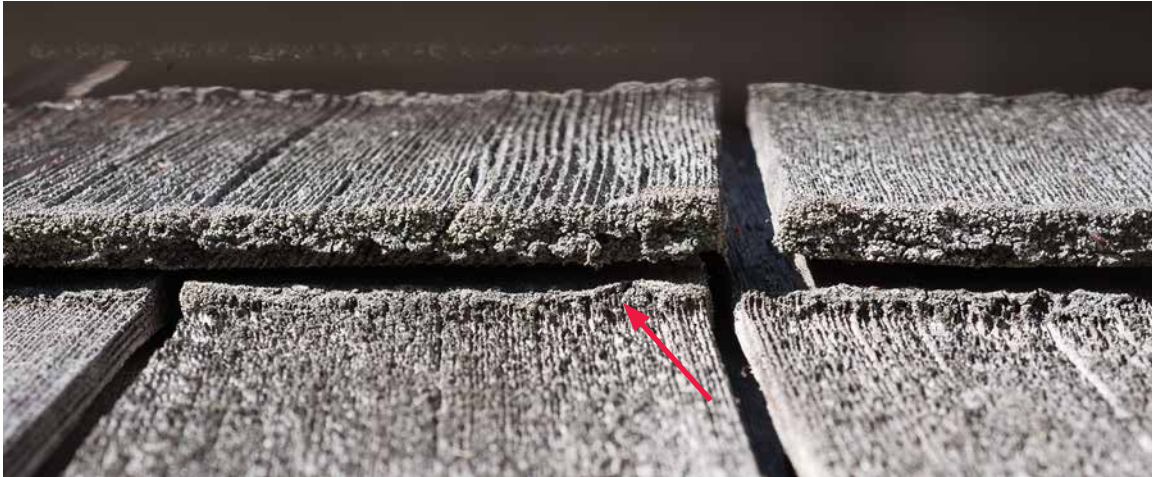
Photo 9: Detail of the south pitch of the rear ell roof shingles showing the extensive erosion to the surface of these shingles that has reduced their original thickness by about 1/3 or more. Their original thickness is visible just under the butts of next course above (arrow).

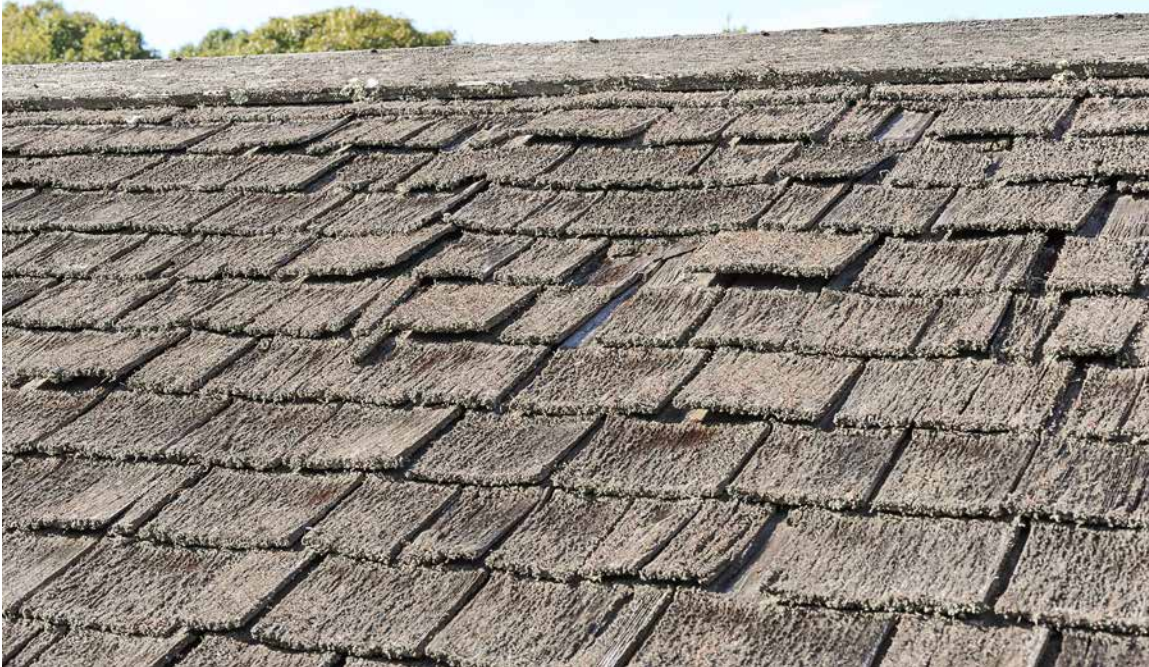
Photo11: Section of the south pitch of the tea room roof showing extensive deterioration from surface erosion and lichen growth. While outside the scope of this assessment, this roof clearly should be redone at the same time as the main house front pitch roof. A number of shingles in this photo can be seen to have broken off at the butt line of the course above them. These shingles are also fastened with stainless steel staples and were installed in 1991.

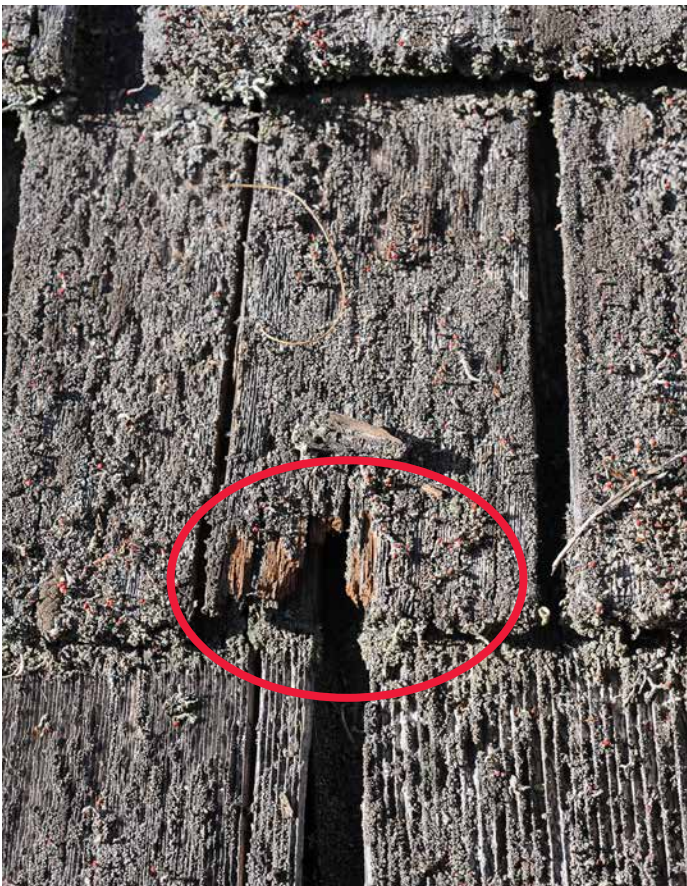
Photo12: Detail of the south pitch of the tea room roof showing where the butt of a shingle is rotted clear through and disintegrating.

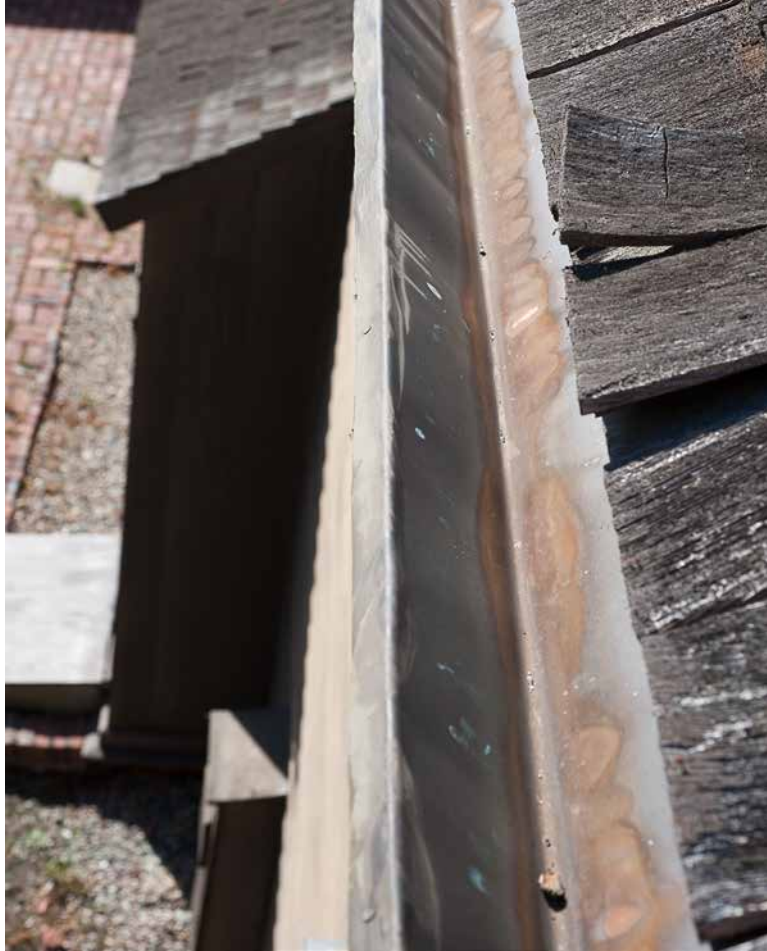
Photo13: The gutters installed in 2007 remain in sound condition and were clear of organic debris at the time of our site visit in October. It is important that they be inspected and cleared of any organic debris on a regular basis.

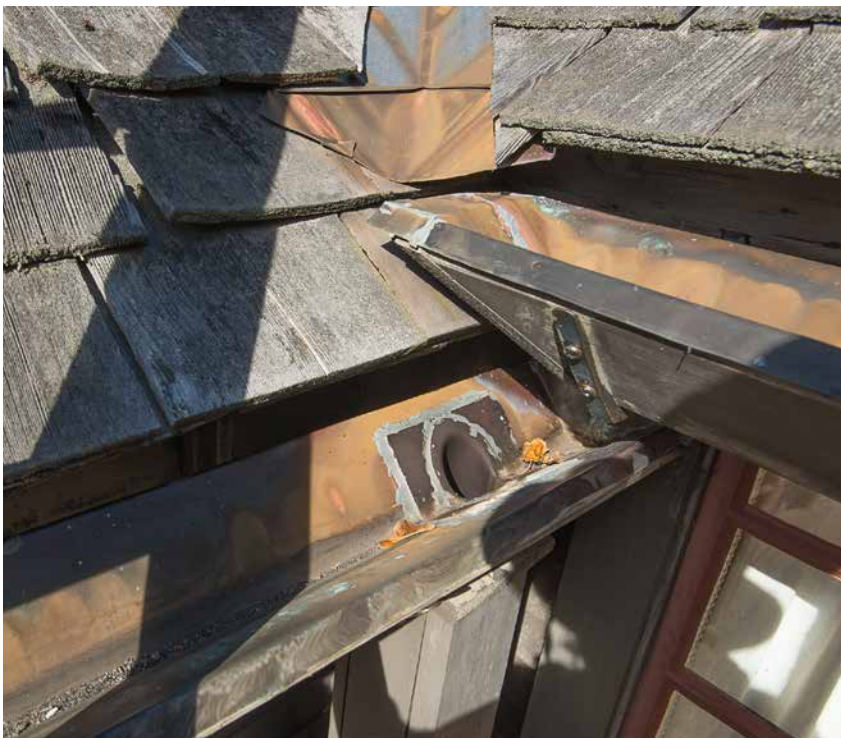
Photo14: gutters showing the top of the downspout. When cleaning the gutters the downspouts should also be checked and cleared of any debris.

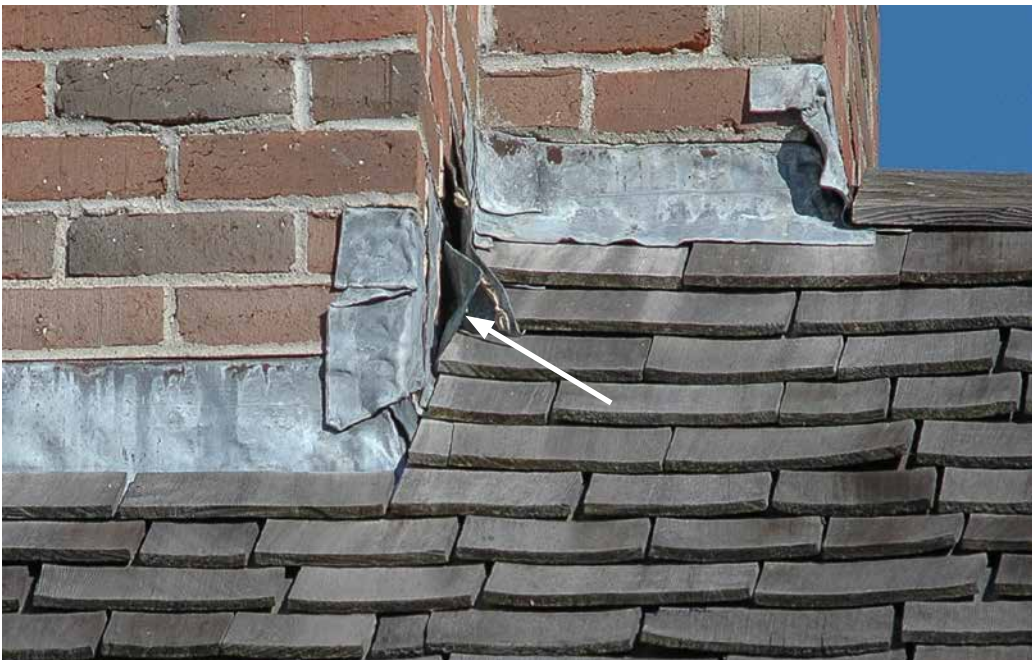
Photo16: Photo taken in 2006 showing the chimney flashing not properly seated against the chimney. Their condition is currently unchanged.

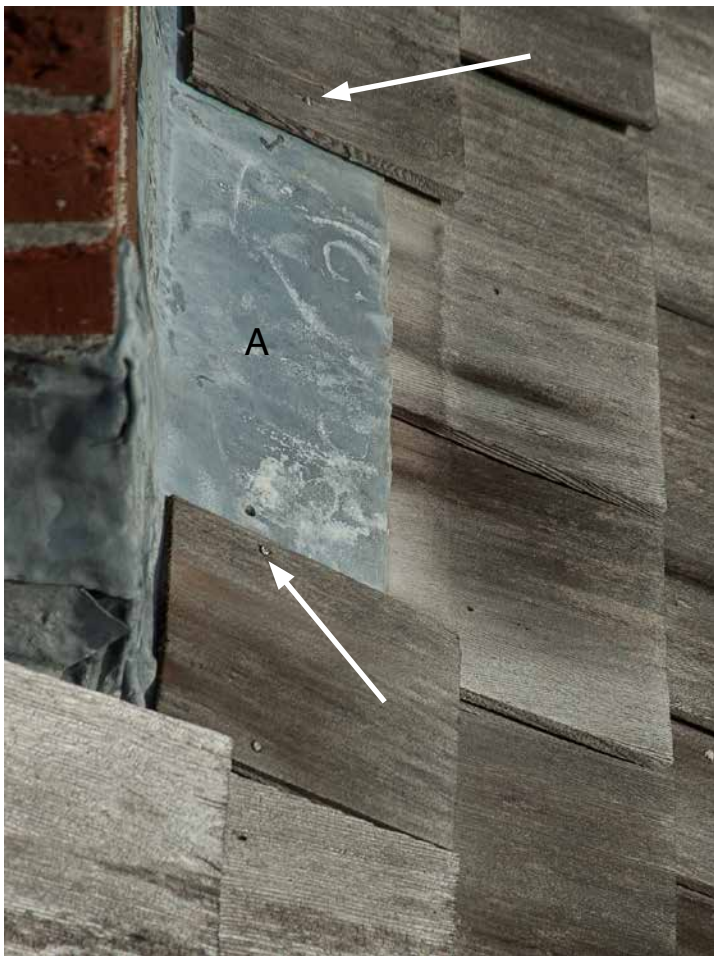
Photo17: Photo taken in 2006 showing the top course of shingles face nailed (arrows) over the lead apron on the downhill side of the chimney and one shingle missing (arrow) with one of its nails sticking out of the flashing and the other leaving a hole in the flashing. Such face nailing can cause leaks. The top course of shingles should be under the flashing with its nails covered by the flashing. If there is a concern about the lead being lifted by the wind, cleats with concealed nailing should be used to hold its lower edge down on top of the shingles. The flashing remains in this condition currently including the missing shingle.

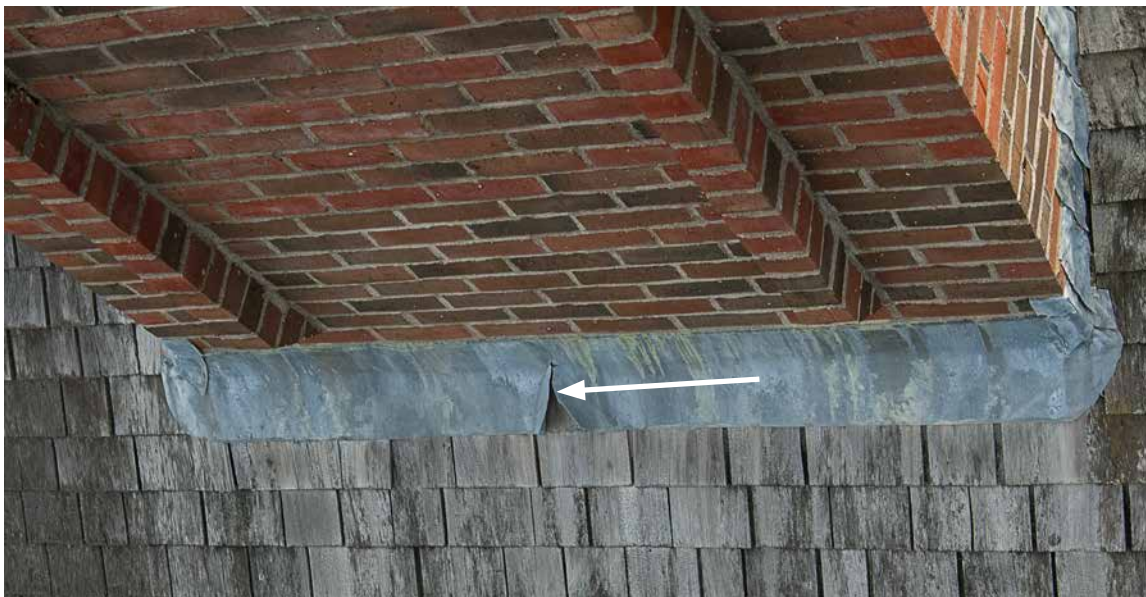
Photo18: Photo taken in 2006 showing a large tear (arrow) in the lead apron flashing on the front side of the chimney. The tear was probably caused by fatigue failure from thermal stress in the long strip of 2 1/2lb. lead. Long exposed pieces of lead should be done using 4 lb. lead to avoid fatigue failure. The flashing remains in this condition today.

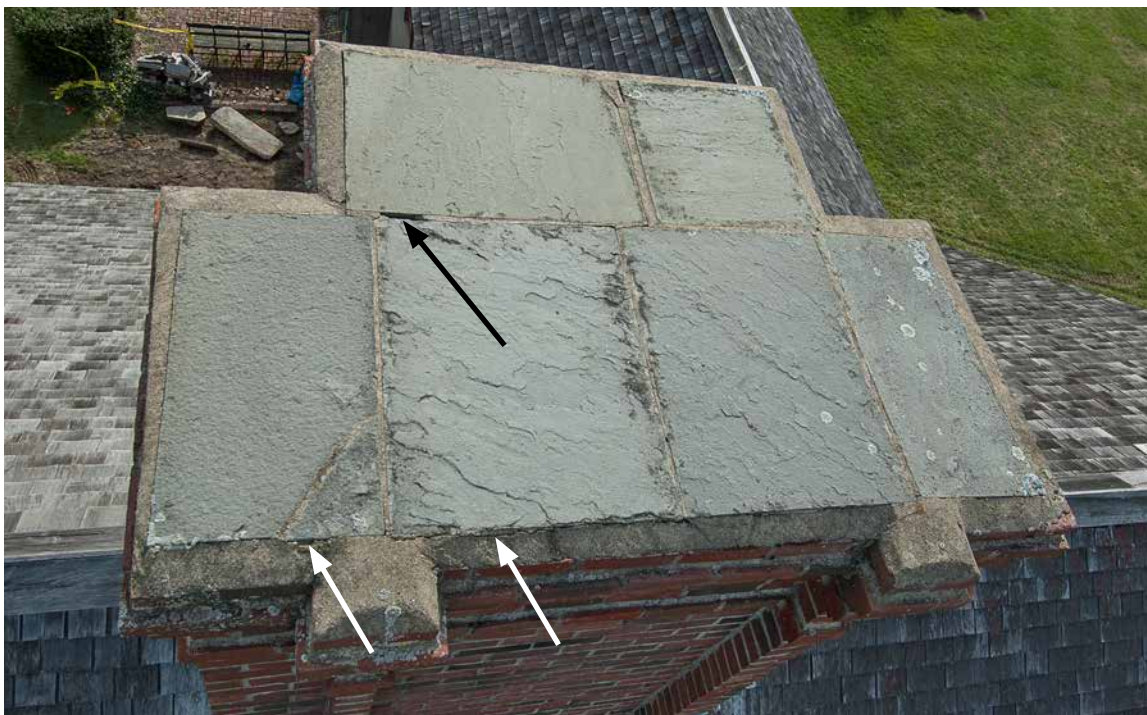
Photo19: Photo taken in 2006 showing the bluestone cap on the main block chimney. The white arrows point to hairline separations between the mortar and the bluestone, the black arrow points to a void in the mortar joint. These defects are probably now worse and can allow water infiltration into the chimney flues. The cap should be inspected when the roof is replaced and defective mortar joints redone. Each piece of bluestone is likely over an individual flue. Replacing a couple of bricks with ventilator bricks would help prevent excessive moisture penetration into the flues due to high internal humidity.

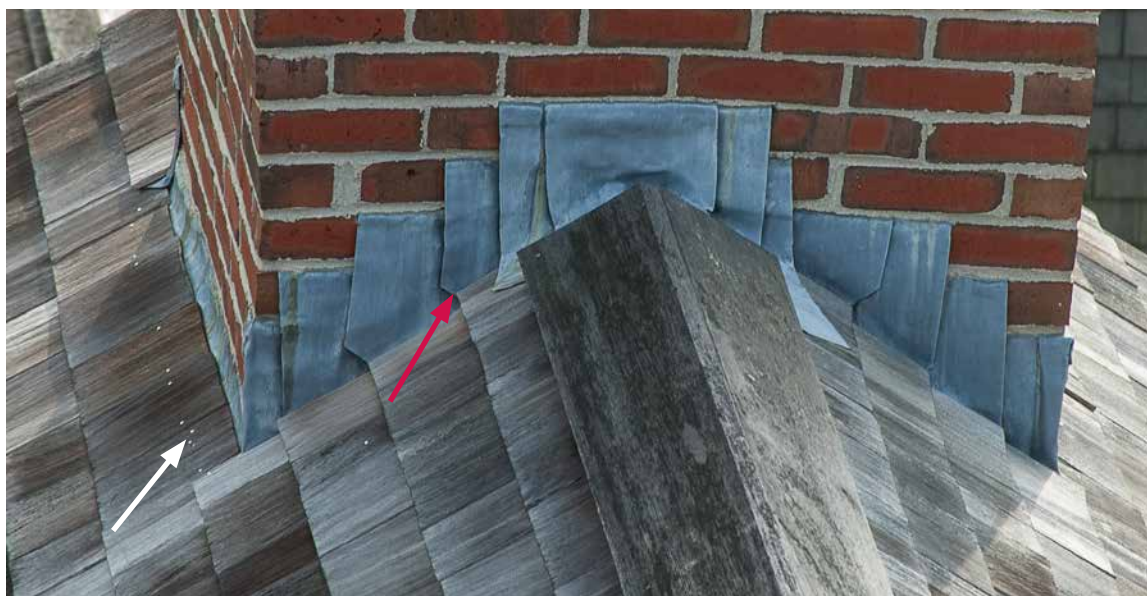
Photo20: Photo taken in 2006 showing the flashing at the rear ell chimney. The white arrow points to face nailing through shingles placed over the apron flashing, which is a problem as discussed at Photo 17. The red arrow points to the lead step flashings that appear to be done as a single piece extending under the shingles. The preferred method is to install two piece flashings consisting of a base flashing and separate counter flashing that covers the upstand of the base flashing. If these lead flashings remain sound they could be trimmed to properly lap over new copper base flashings when the roof is redone.

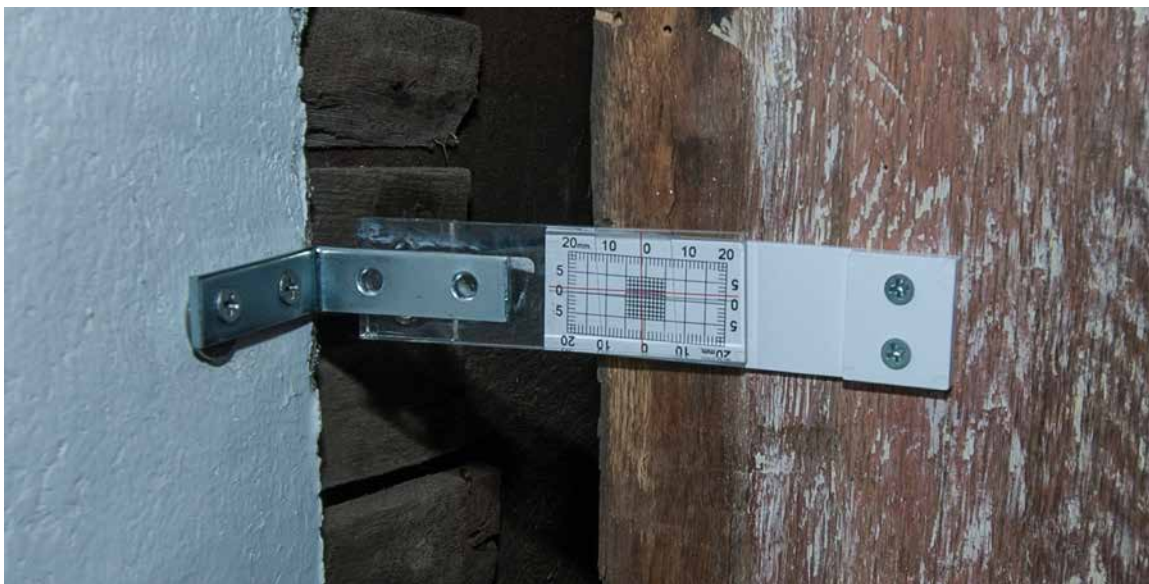
Photo 21: Photo taken in 2005 showing the crack gauge between the main block on the left side and the southeast corner post of the rear ell just after it was installed. The purpose of the gauge was to determine if there is any current movement between the two portions of the building.

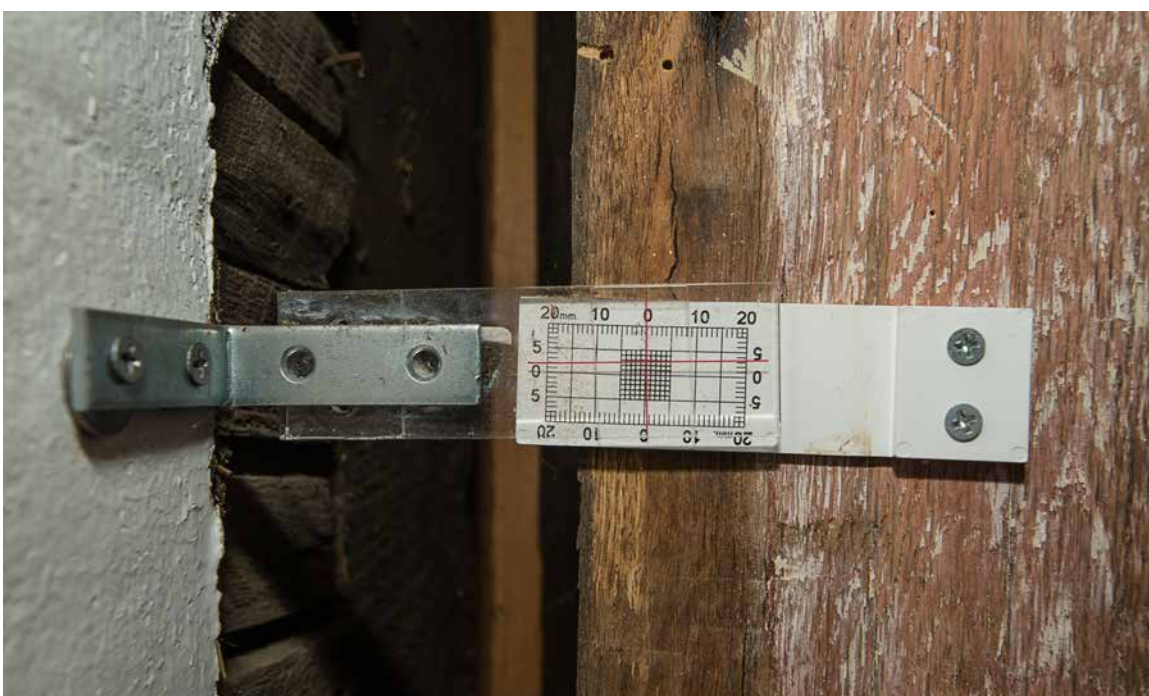
Photo 22: Photo taken in 2016 showing the current position of the red cross hairs on the crack gauge shown in photo 21. The purpose of the gauge was to determine if there is any current movement between the two portions of the building. The slight difference in the position of the cross hairs between the two photos is probably due to the camera angle in photo 21 being slightly off center (above and to the left of the cross hairs) whereas in photo 22 it is straight over the cross hairs. The photos demonstrate that there has been no significant movement over the last ten years and the relationship between the ell and the main block is stable. The original cause of the separation is not known, but it was once covered by a piece of trim that extended from the unpainted portion of the corner post to the plaster lath on the left.

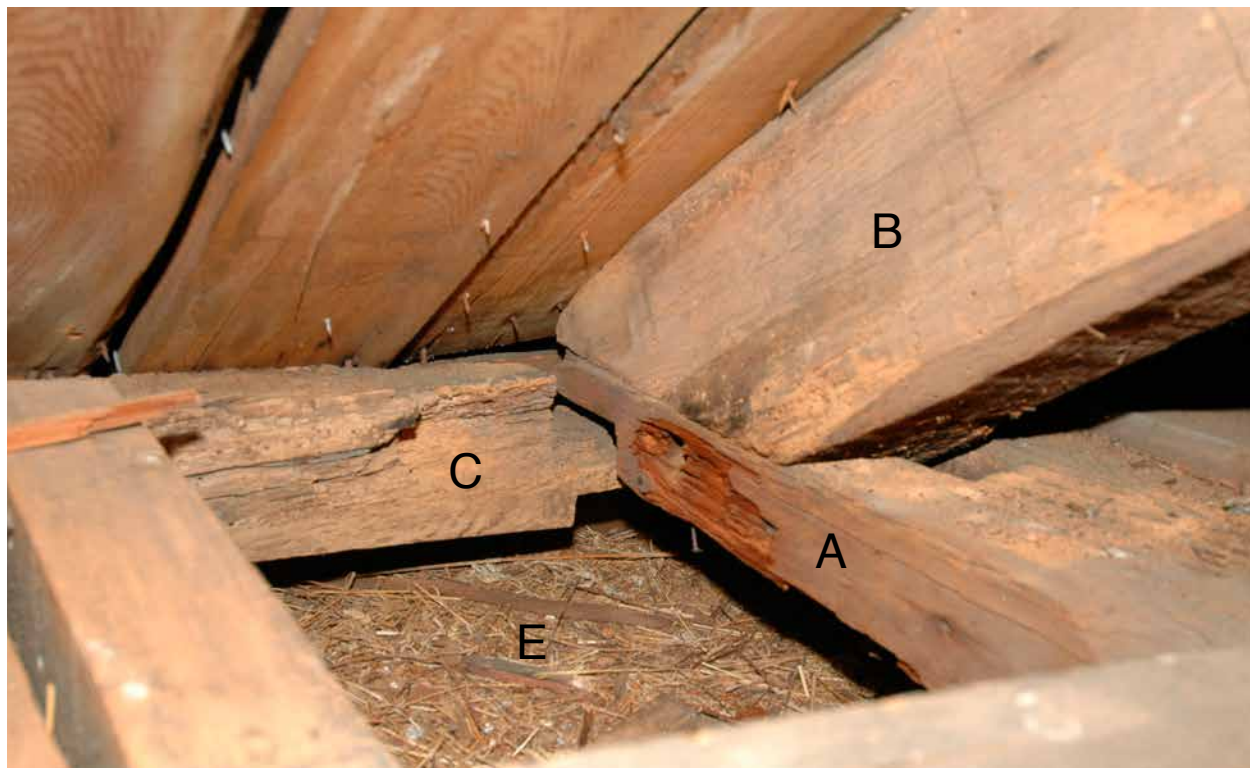
Photo 23: Photo taken in 2005 of the end of the southerly chimney girt (A) and rafter (B) above the front entry. “C” is lowest common purlin that carries the bottom of the roof sheathing over the roof cornice and soffit. The debris at “E” is on top of the cornice soffit. The bottom half of the girt has rotted away.

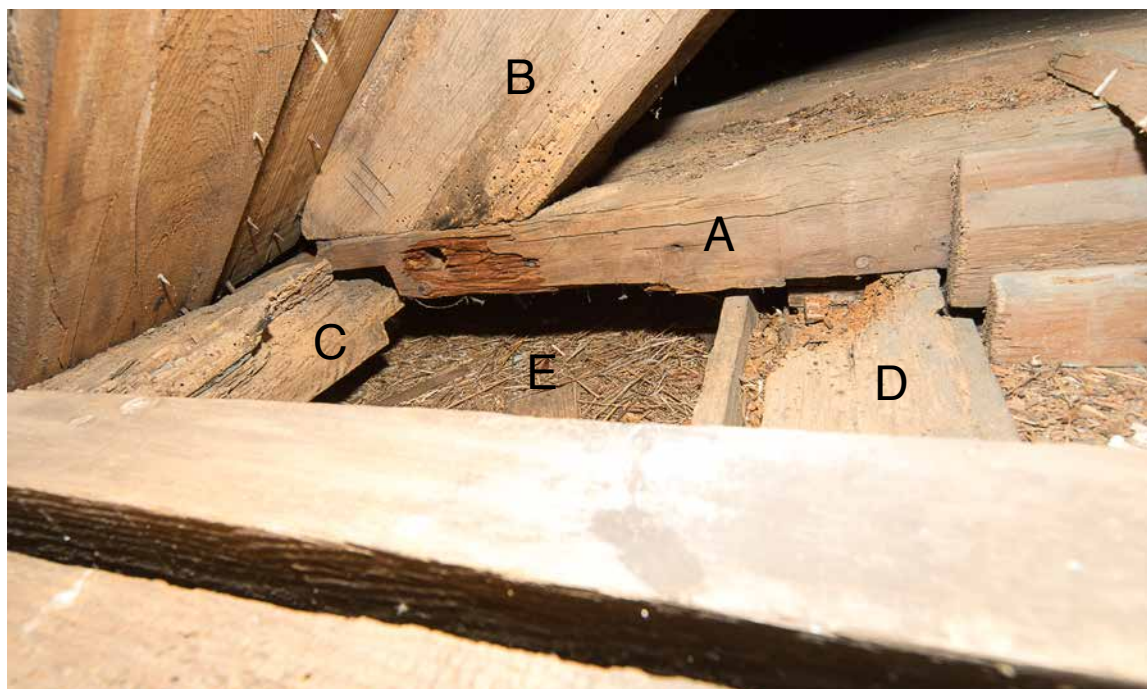
Photo 24: Photo of the end of the southerly chimney girt taken in 2016 showing that its current condition is essentially the same as in 2005. “D” marks the east wall plate (i.e., roof plate) which carries the chimney girt as it passes over it. The end of the girt and the rafter are essentially cantilevered beyond the roof plate. The roof cornice at this location when viewed from the exterior does not show any major sagging or deformation.

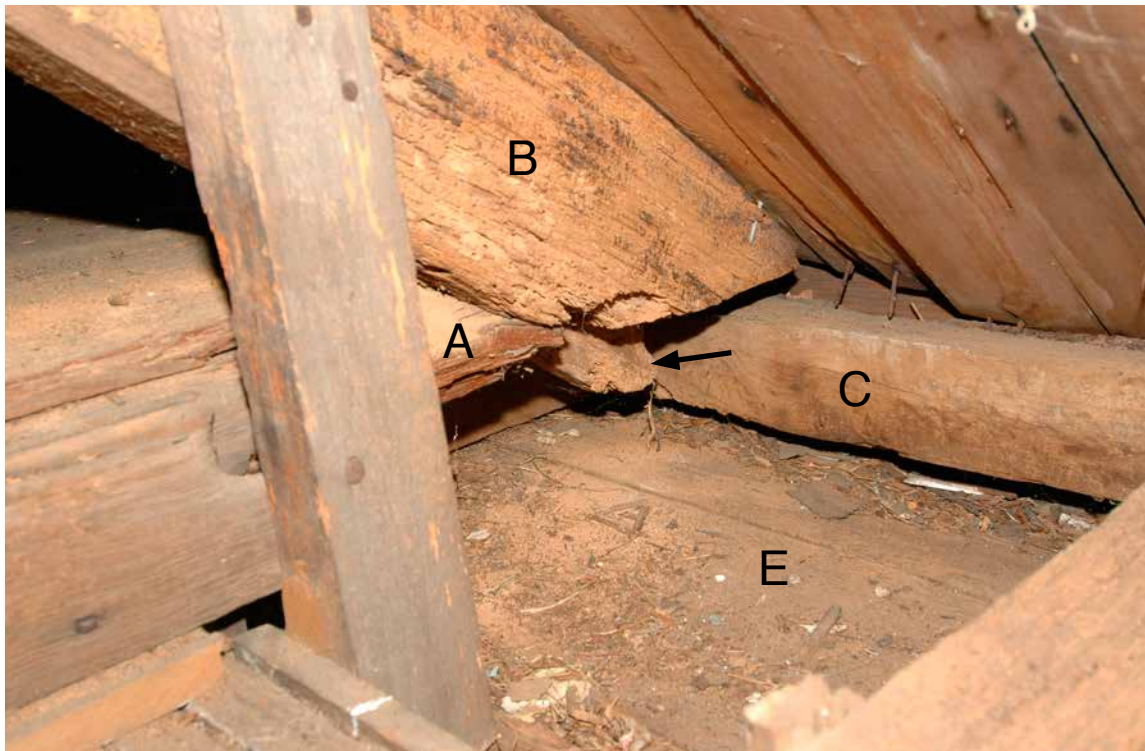
Photo 25: Photo of the end of the northerly chimney girt taken in 2005. The boards forming the cornice soffit are marked "E". The arrow points to the tenon of the rafter that was originally housed in a mortise in the chimney girt. The mortise along with the bottom half of the girt has completely rotted away.

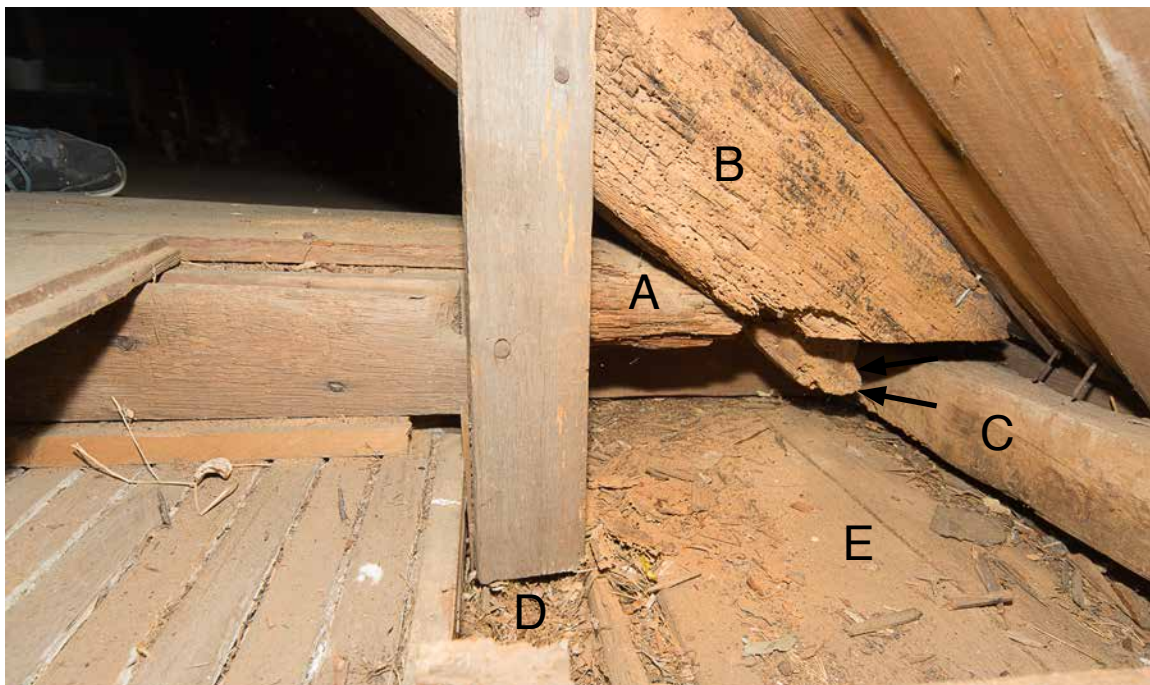
Photo 26: Photo of the end of the northerly chimney girt taken in 2016. The boards forming the cornice soffit are marked "E". As at the northerly chimney girt, current conditions are unchanged from 2005.

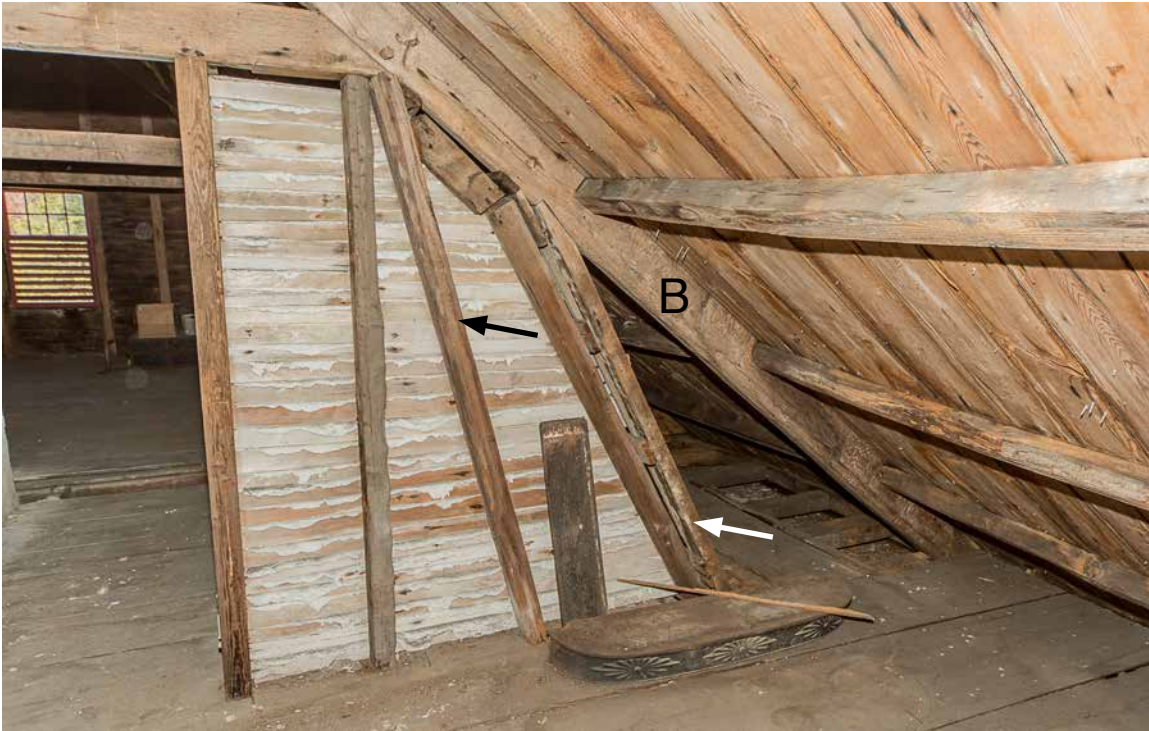
Photo 27: Photo taken in 2016 showing the southerly chimney rafter (B) and the south side of the ca. 1920 attic stair enclosure. The arrows point to an angled post a stud that are seated on the sound portion of the southerly chimney girt. These are probably transferring a significant portion of the roof load from the rafter to the girt. The framing on the south side of the enclosure is similar.

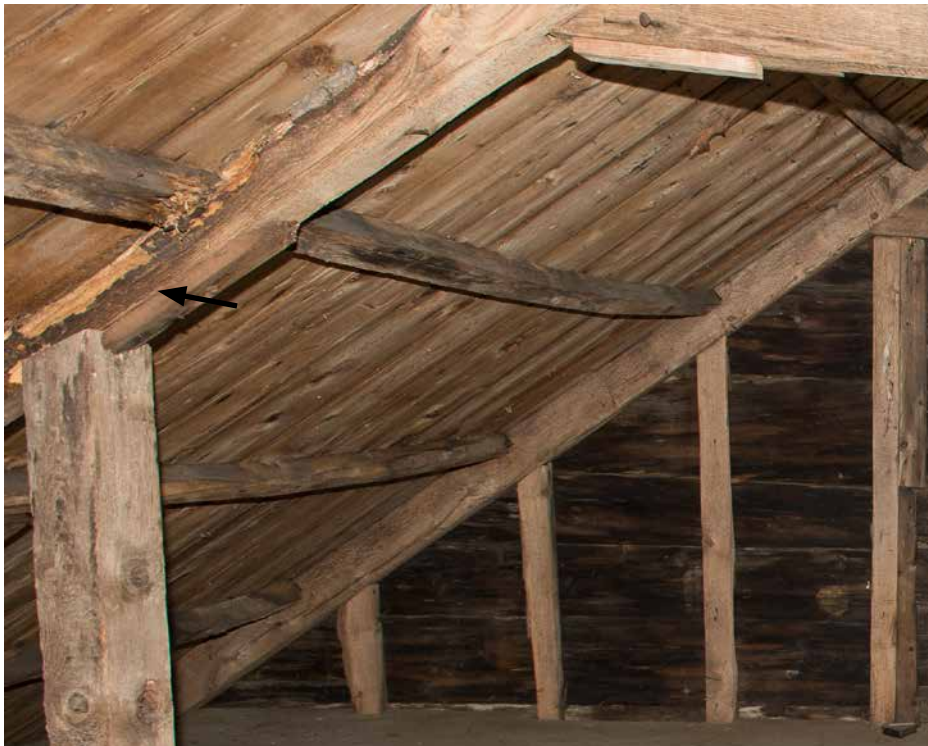
Photo 28: Photo looking toward the south end gable wall showing substantial sag in the common roof purlins as well as past rot in the rafter marked by the arrow. The purlins are undersized by modern standards and their sag has probably been present for many years.

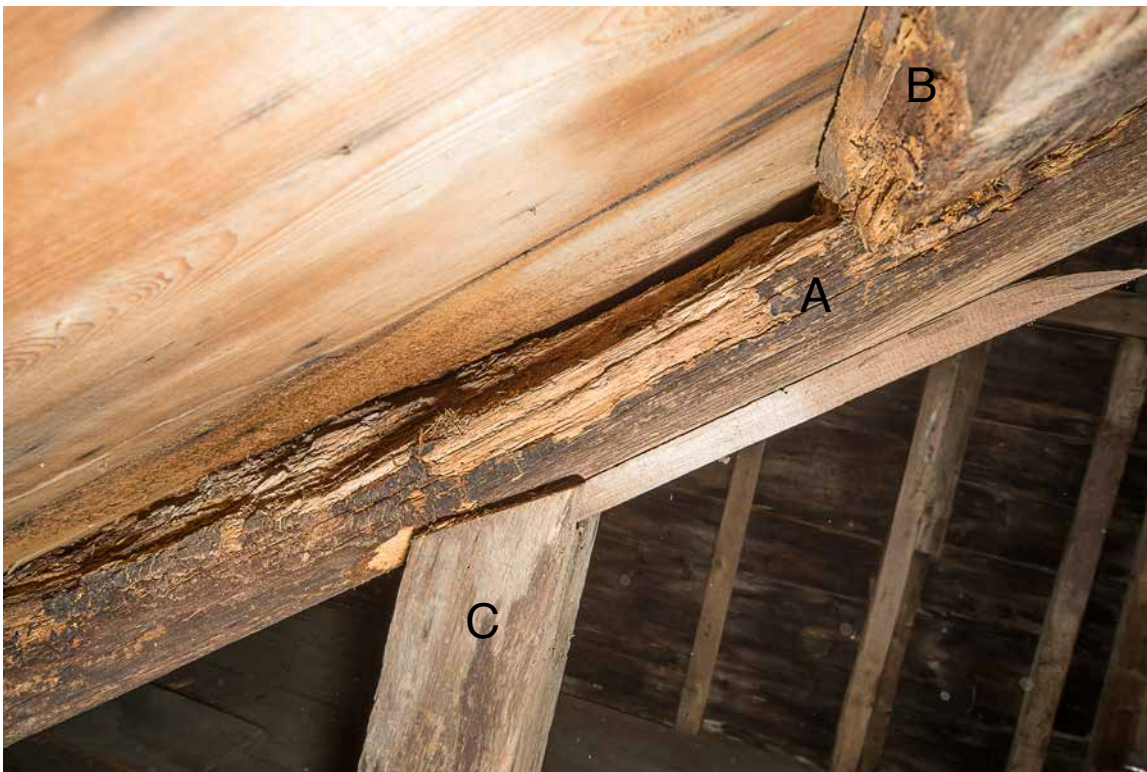
Photo 29: Detail of the rafter (A) marked with the arrow in photo 28 and the purlin that passes over it (B). The strut marked “C” was added some time ago to help support the damaged rafter. The upper third of the rafter is severely rotted, as is the purlin where it passes over the rafter. As the roof sheathing does not show rot above the rafter, the damage must have occurred prior to the installation of the current roof sheathing.
