ARCHITECTURAL CONDITIONS ASSESSMENT

December 31, 2016

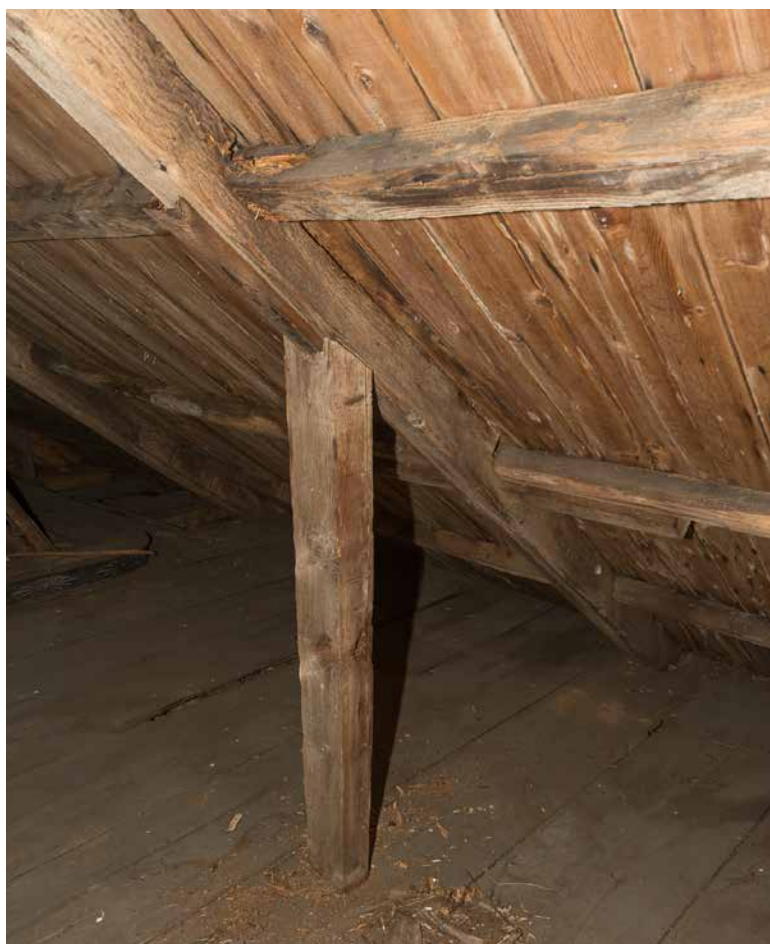
Photo 30: Overview of the damaged rafter and purlin in photo 29 showing the strut (C) that been added to carry loads from the weakened rafter down to the girt under the floor boards. While it probably has prevented failure of the rafter, it does not prevent future failure of the purlin where it passes over the rafter. The conditions at this location should be evaluated by a carpenter with substantial experience repairing 18th century timber framing and repaired as needed.

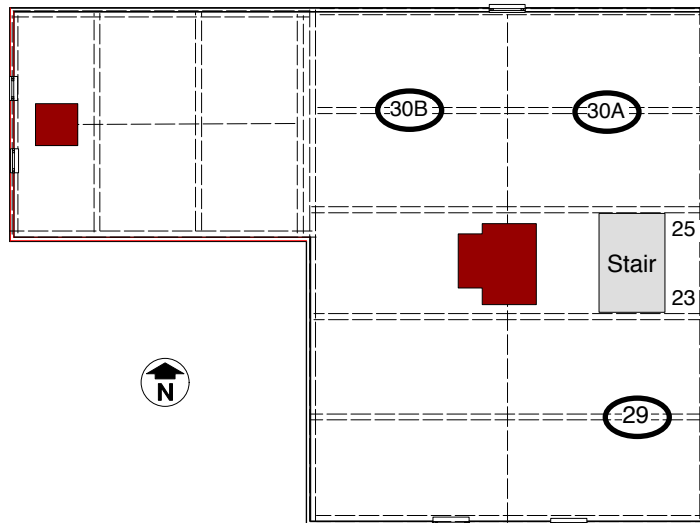
Plan 1: Plan of attic. Double dashed lines are principal roof rafters. The numbers refer to photographs of specific areas of concern.

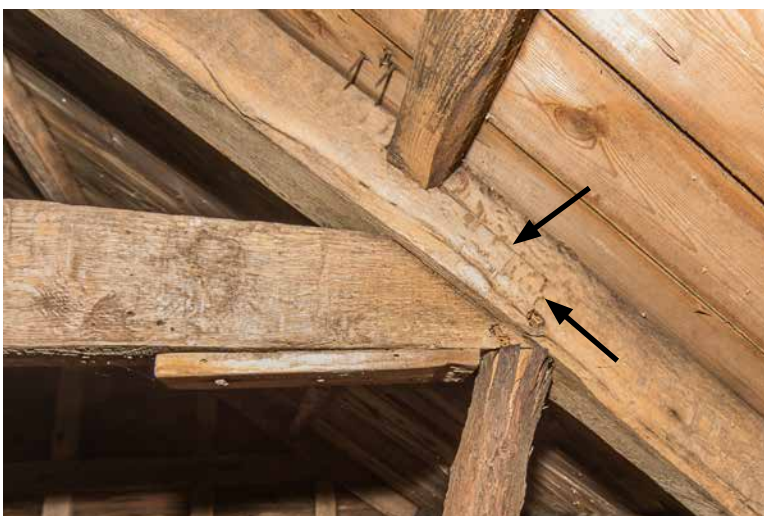
Photo 30A: Junction of rafter tie beam with easterly principal rafter with make-do strut below the joint. The photo is looking toward the north attic gable end. The arrows point to what may be stress cracking. Numerous exit holes in both the rafter and the end of the tie beam indicate past insect activity at this joint. Further evaluation of conditions at this joint is warranted.

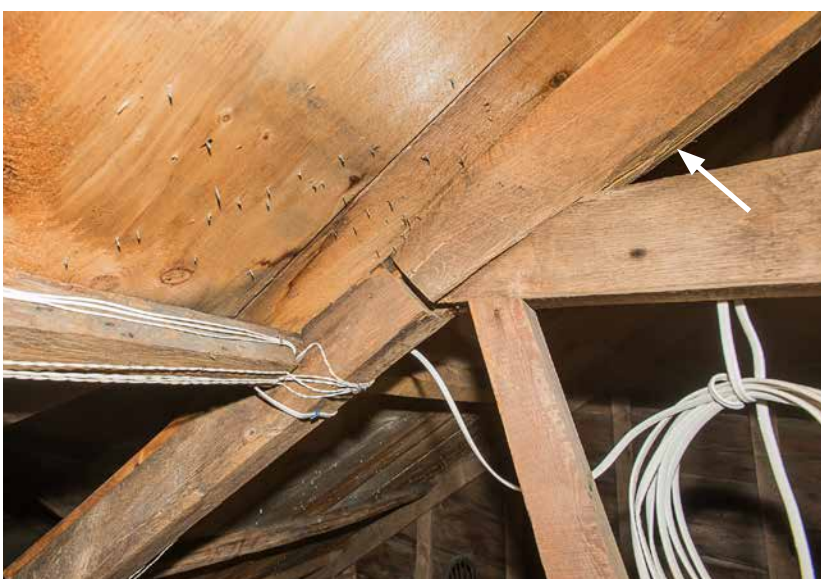
Photo 30B: Junction of rafter tie beam with the westerly principal rafter looking toward the north attic gable end. The portion of the rafter from the bottom of the tie beam upwards appears to be a modern replacement that is spliced to the portion of the original rafter that remains below the tie beam. The arrow points to checks in the underside of the rafter that appear to originate at the splice joint. Further evaluation of conditions at this joint is warranted.

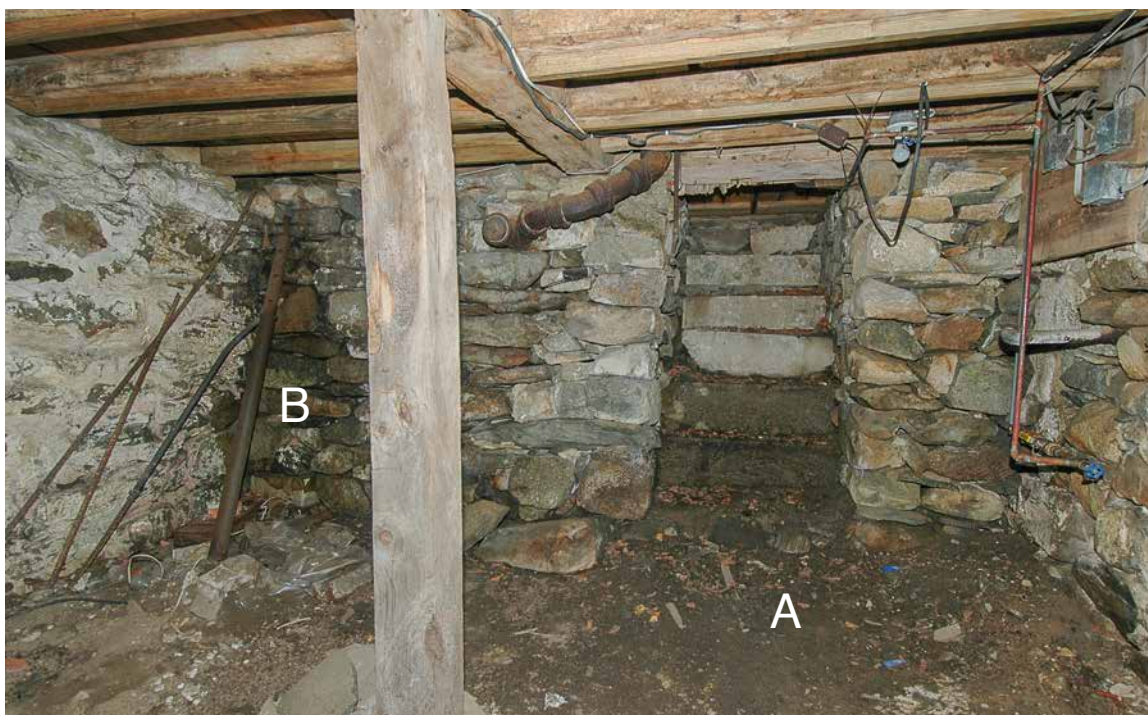
Photo 31: Overview taken in 2005 of the south end of the cellar below the rear ell showing excessive moisture seeping into the space. The darkened soil at “A” is very wet from water seeping in through leaks in the bulkhead at the stairs. The foundation wall at “B” is also dark from water seeping in below the junction of the ell with the main block.

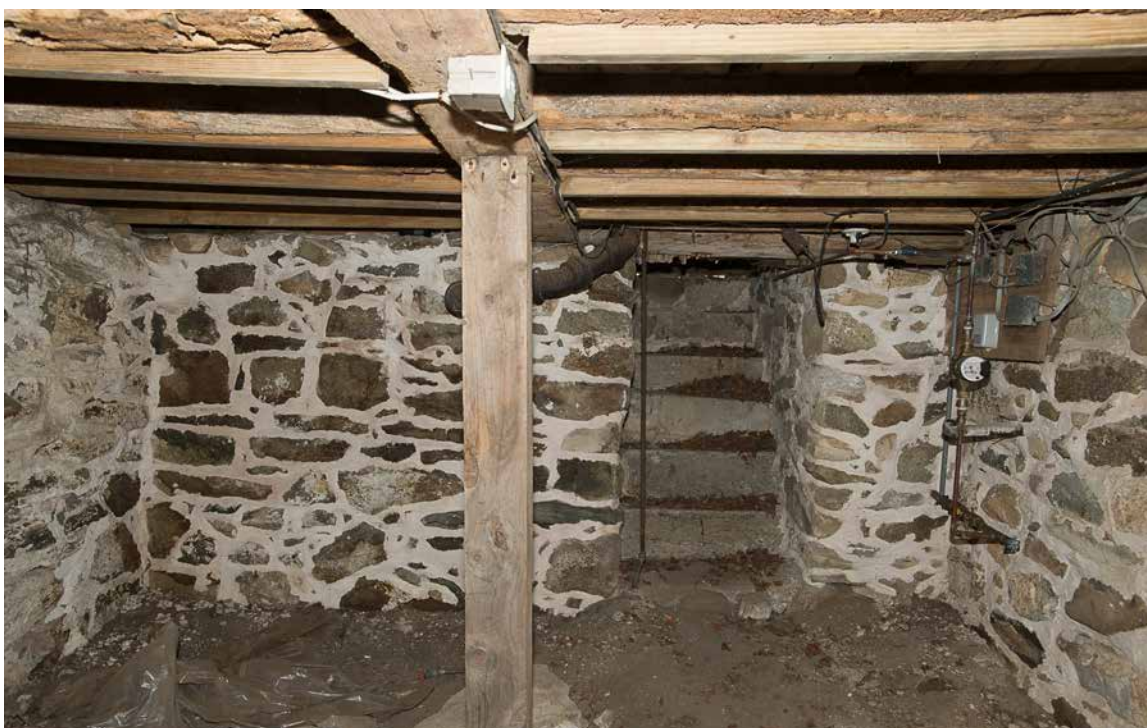
Photo 32: Overview taken in 2016 of the south end of the cellar below the rear ell. The walls were repointed in 2006-7 along with rebuilding the bulkhead cover and adding gutters below the roof. The soil was dry and there were no signs of seepage through the foundation wall. Examination by Peter Krusell after periods of heavy rain did not show any signs of seepage. That the data logs recorded this year still showed high relative humidity is probably a function of vapor transmission from the soil and the foundation walls.

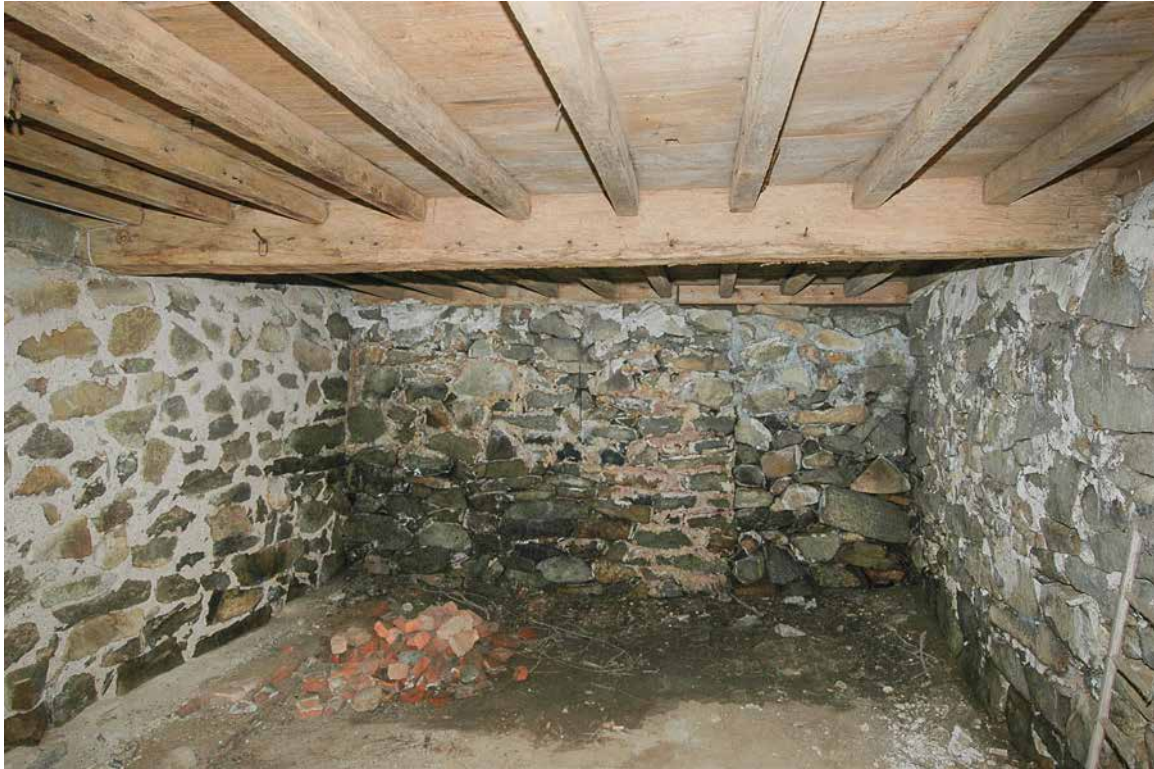
Photo 33: Overview taken in 2005 of the south end of the main block cellar below the kitchen showing excessive moisture seeping into the space indicated by the dark areas on the dirt floor and the foundation wall.

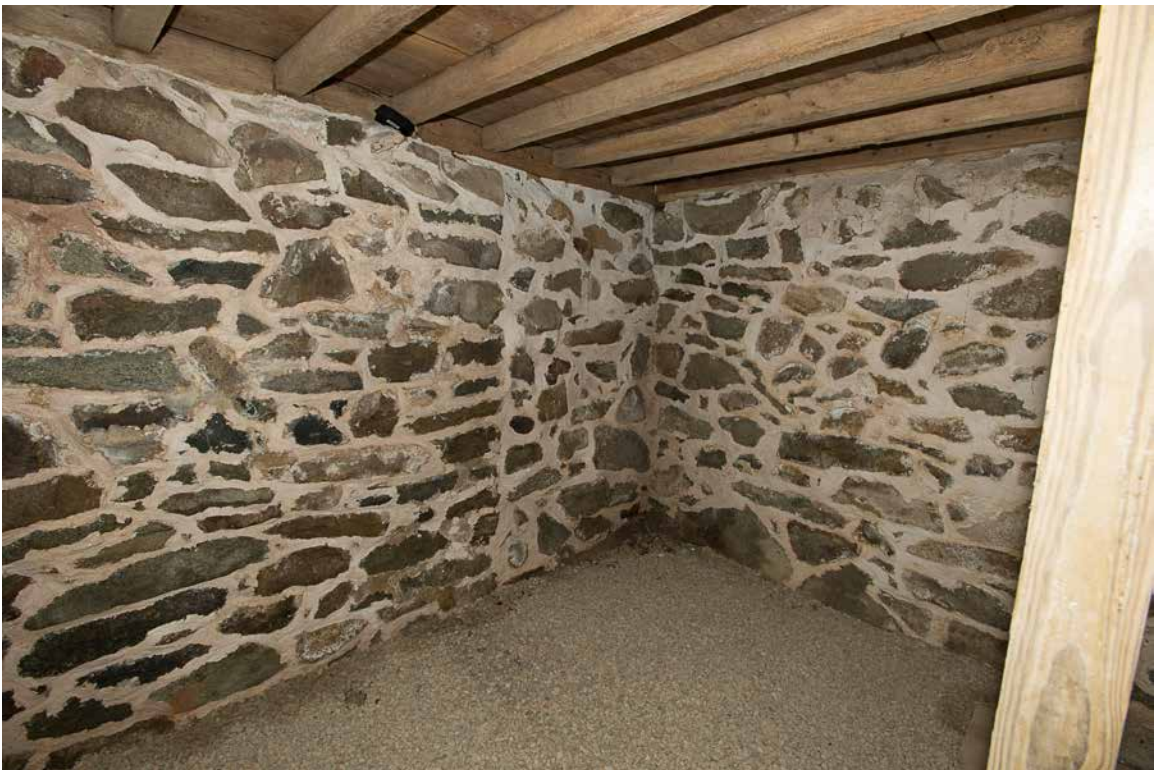
Photo 34: Overview taken in 2016 of the south end (left) and north side (right) of the main block cellar below the kitchen showing the repointing of the foundation done in 2006-7 and the gravel installed over the dirt floor. There are no signs of substantial seepage.

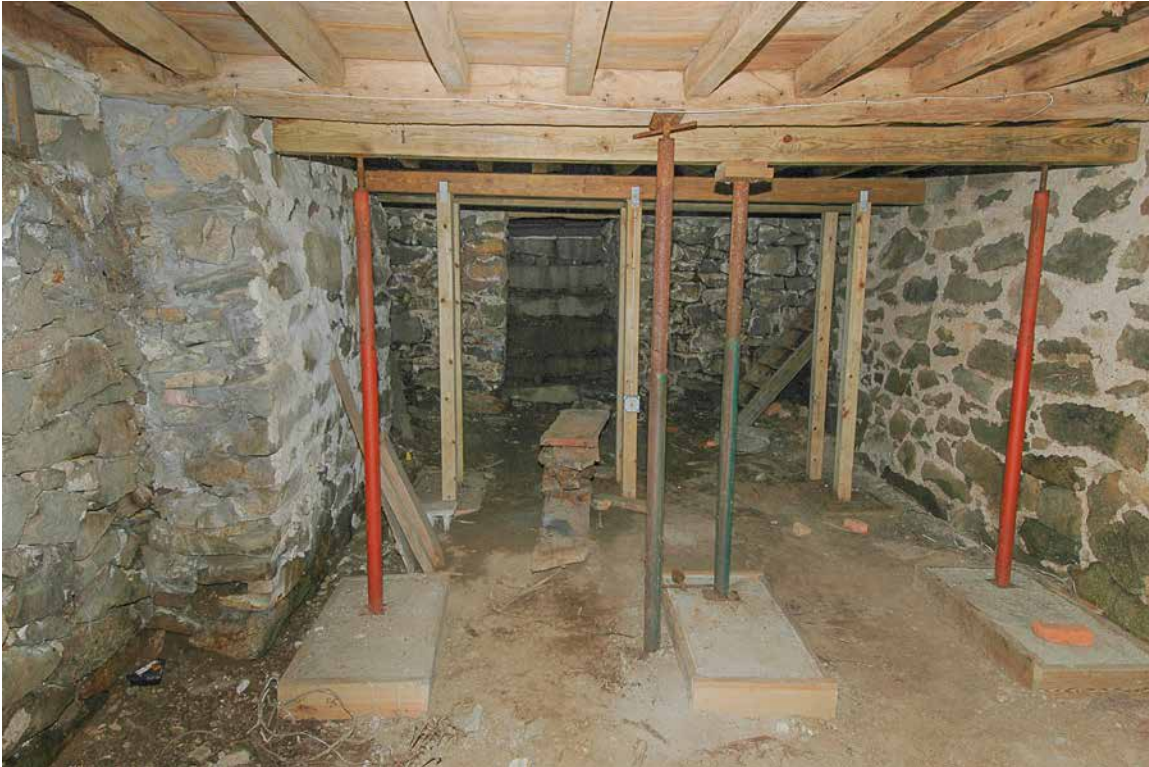
Photo 35: Overview taken in 2005 of the main block cellar below the kitchen looking towards its north end. Dark areas on the dirt floor indicate excessive moisture seeping into the space. Some of the support for the ceiling framing is provided by metal screw jacks which are not considered stable for long term support.

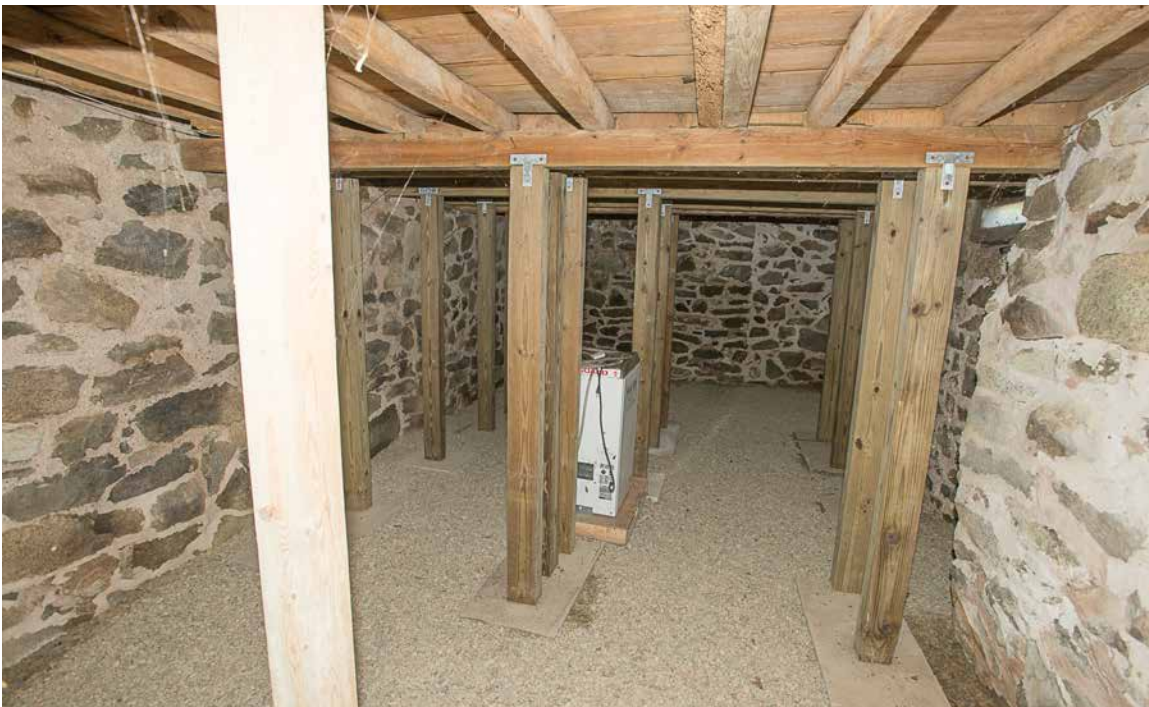
Photo 36: Overview taken in 2016 of the main block cellar below the kitchen looking towards its south end. The dirt floor has been covered with a plastic vapor barrier with gravel above it. The metal screw jacks have been replaced with wood posts footed on concrete pads. There are no signs of significant seepage, although the RH remains high.

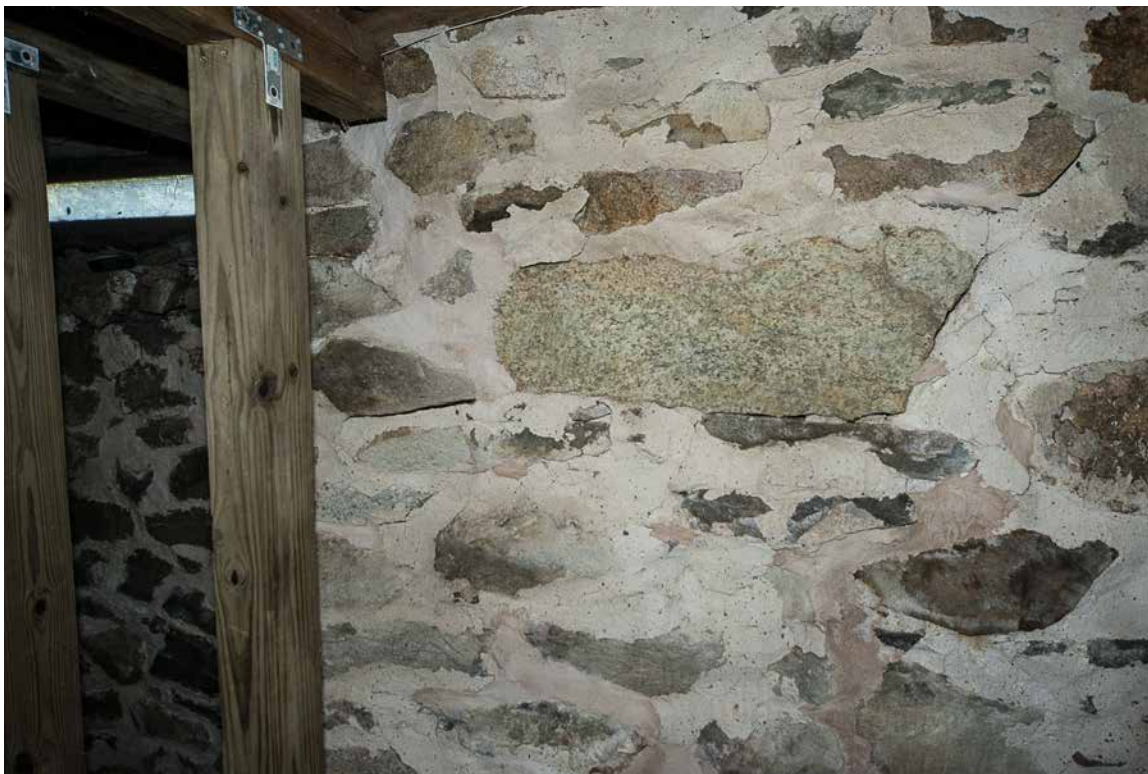
Photo 37: Photo taken in 2016 of the main block cellar below the kitchen showing a small section of its west wall that has some voids in the joints where the mortar butts the stone. The voids due not show up in this photo, but comparison with the 2005 photo shows that both the cracks and the existing mortar predate 2005 and are not a concern.

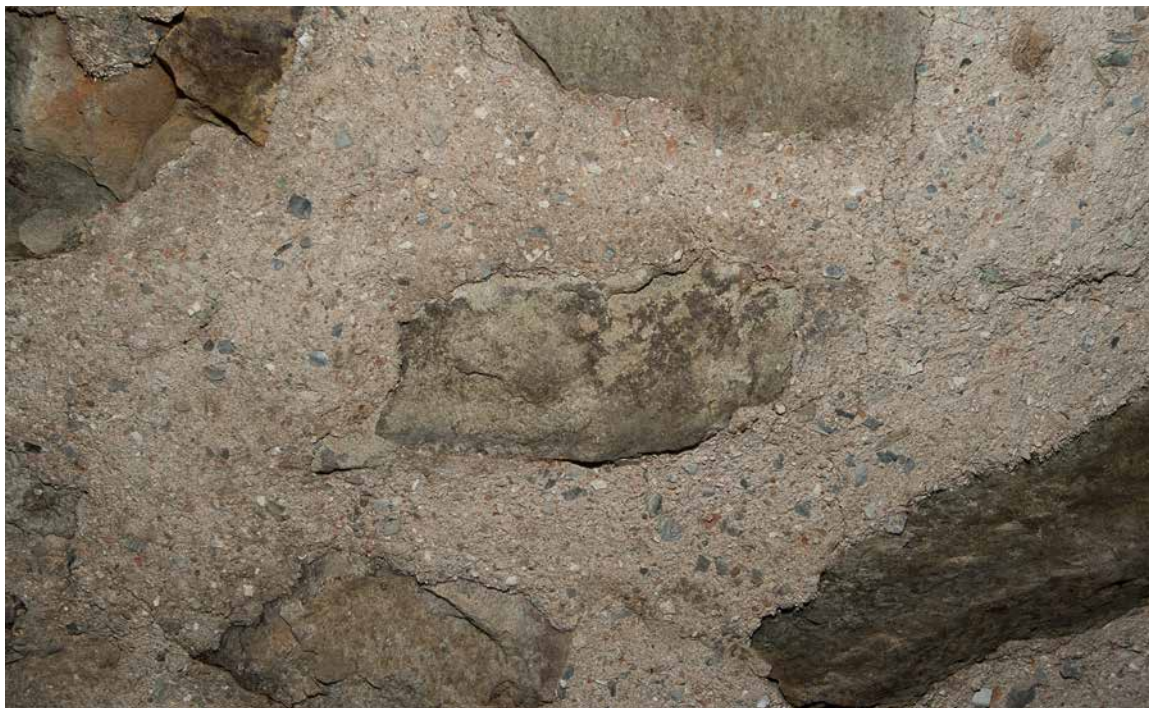
Photo 38: Detail of the mortar joints in the east wall of the main block cellar. The mortar is probably original to the house or very early as it has numerous particles of shells in it that indicate it was made by burning sea shells rather than limestone. It has a distinctive light reddish brown color. As a rare survival of very early mortar it should be retained and preserved. Is is generally in sound condition.

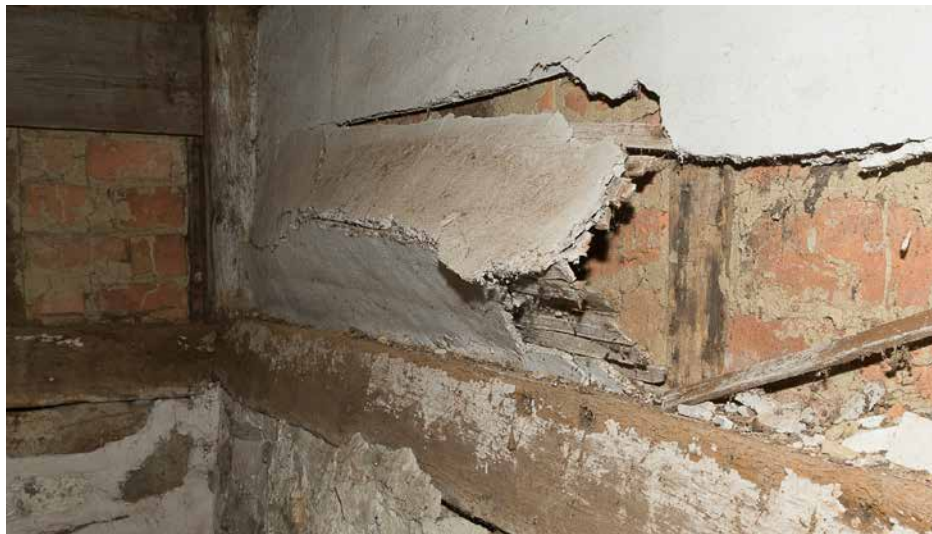
Photo 39: Buckled plaster on the north wall of the dairy. The buckling is more severe than it is in the 2005 photo below. It does not, however, indicate structural issues. It is simply collapsing from its own weight. It could be carefully re-secured to the studs behind it using plaster washers and screws to preserve it.

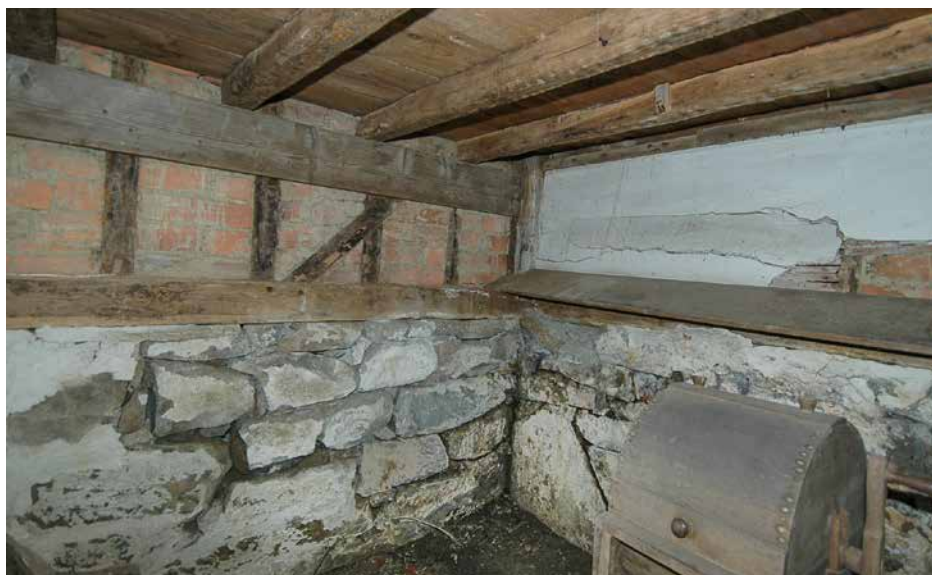
Photo 40: Photo of the north (right) and west walls of the dairy in 2005 showing the buckled plaster on the north wall. The mortar joints in the foundation wall are severely eroded.

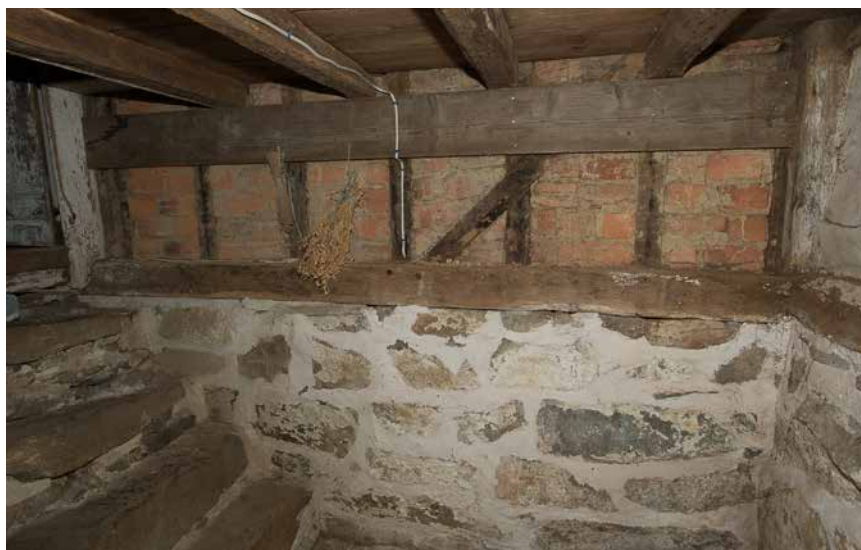
Photo 41: Photo of the west walls of the dairy in 2016 showing the repointing of the foundation that was done in 2006-7. There is brick noggling set in clay mortar between the studs which suggests this wall was originally an exterior wall of the house.

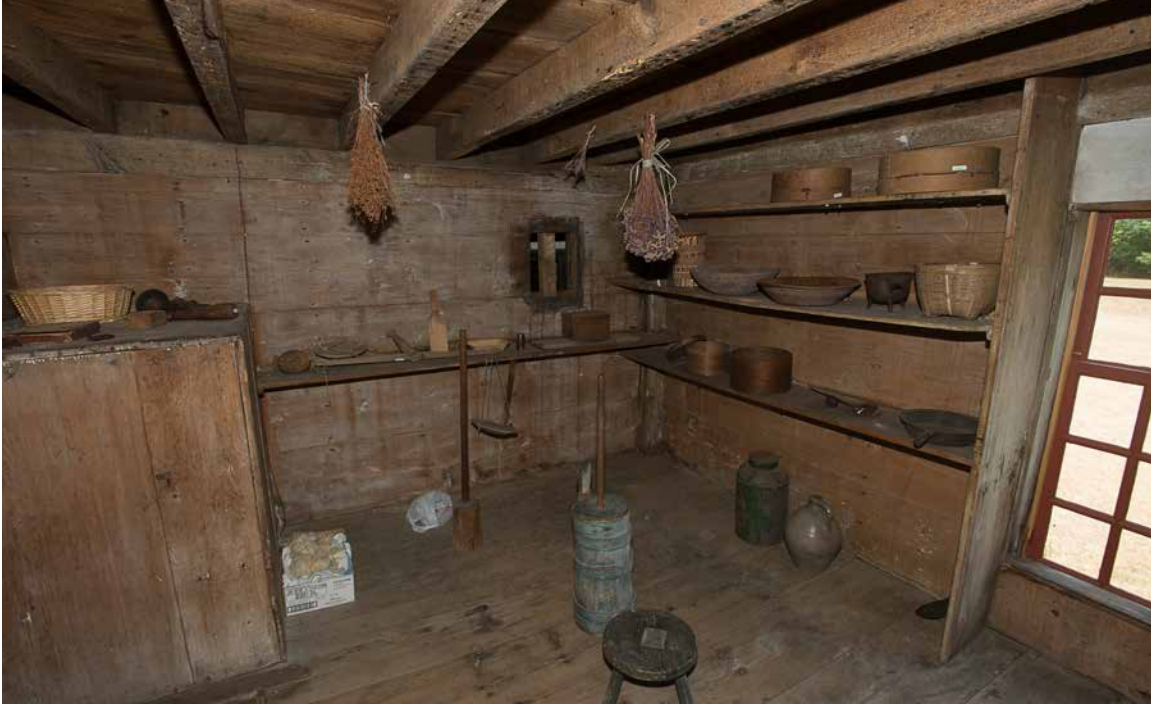
Photo 42: Photo of the north and west walls of the pantry in 2016. It probably had a plaster ceiling when originally constructed, as there is no remnant of whitewash above the bottom of the joists and on the wall girts.

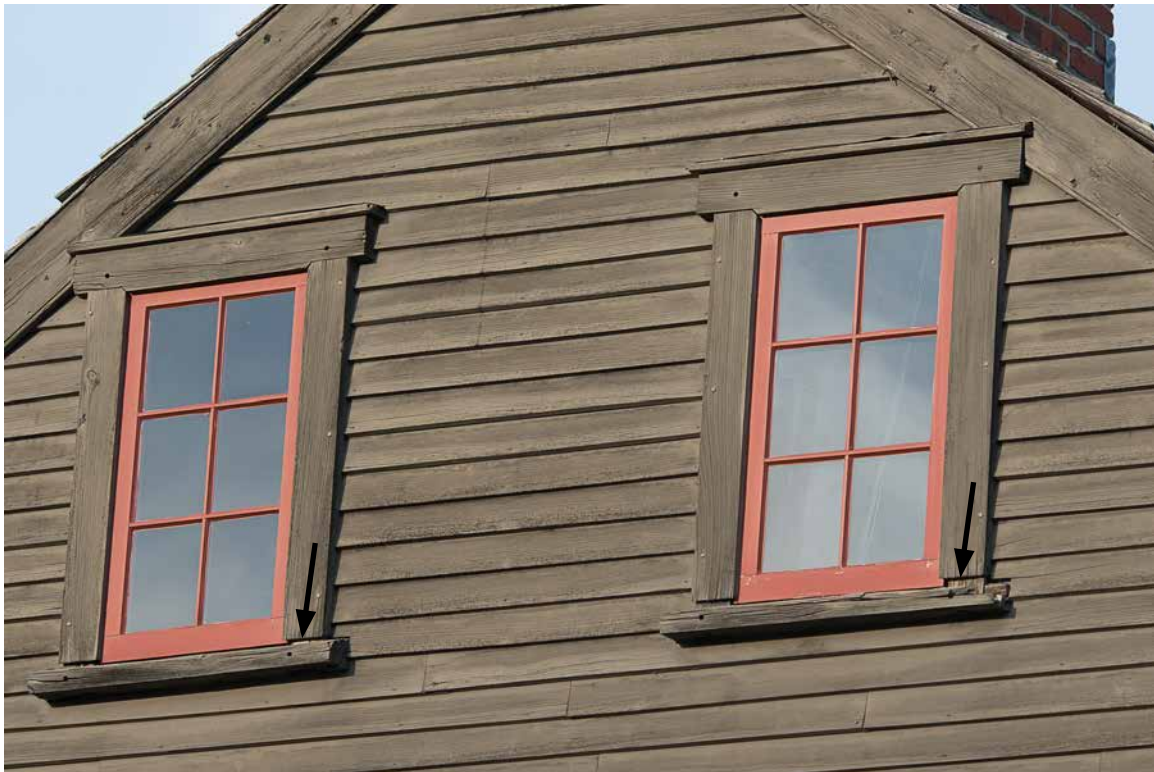
Photo 44: West attic wall of the main block showing two windows where the sills have slipped down exposing the tenons of the jambs (arrows). The frames of these two windows were not repaired in the 2006-7 work, perhaps because access was difficult.

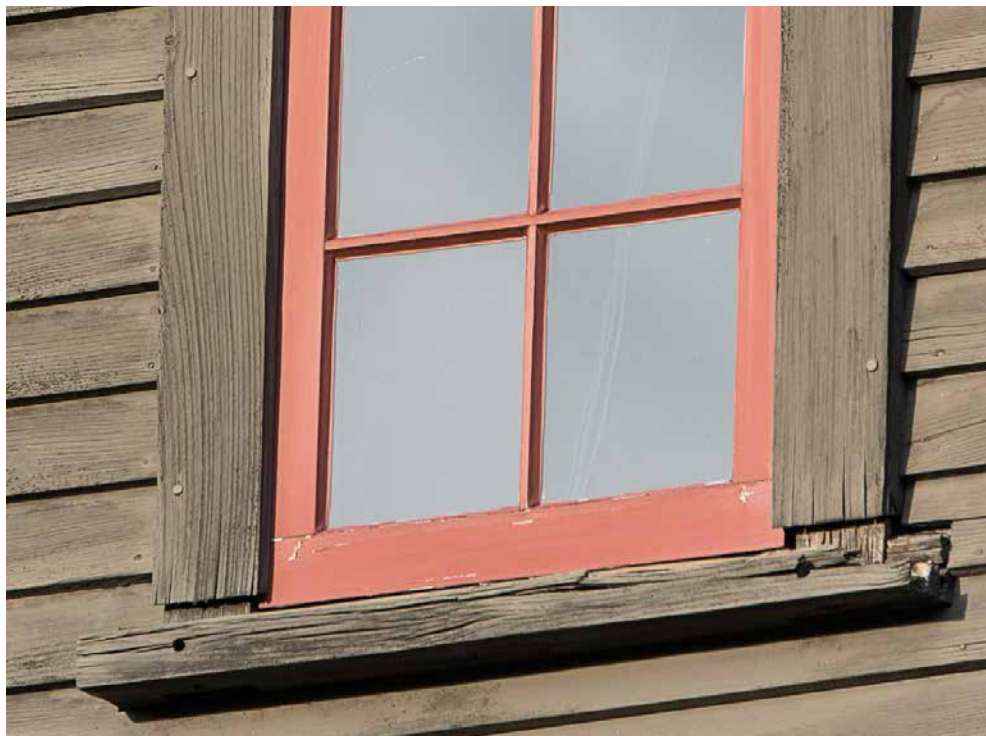
Photo 45: Detail of the southerly window showing that the sill has partially rotted away around the tenon of the right side jamb. This sill needs to be replaced.

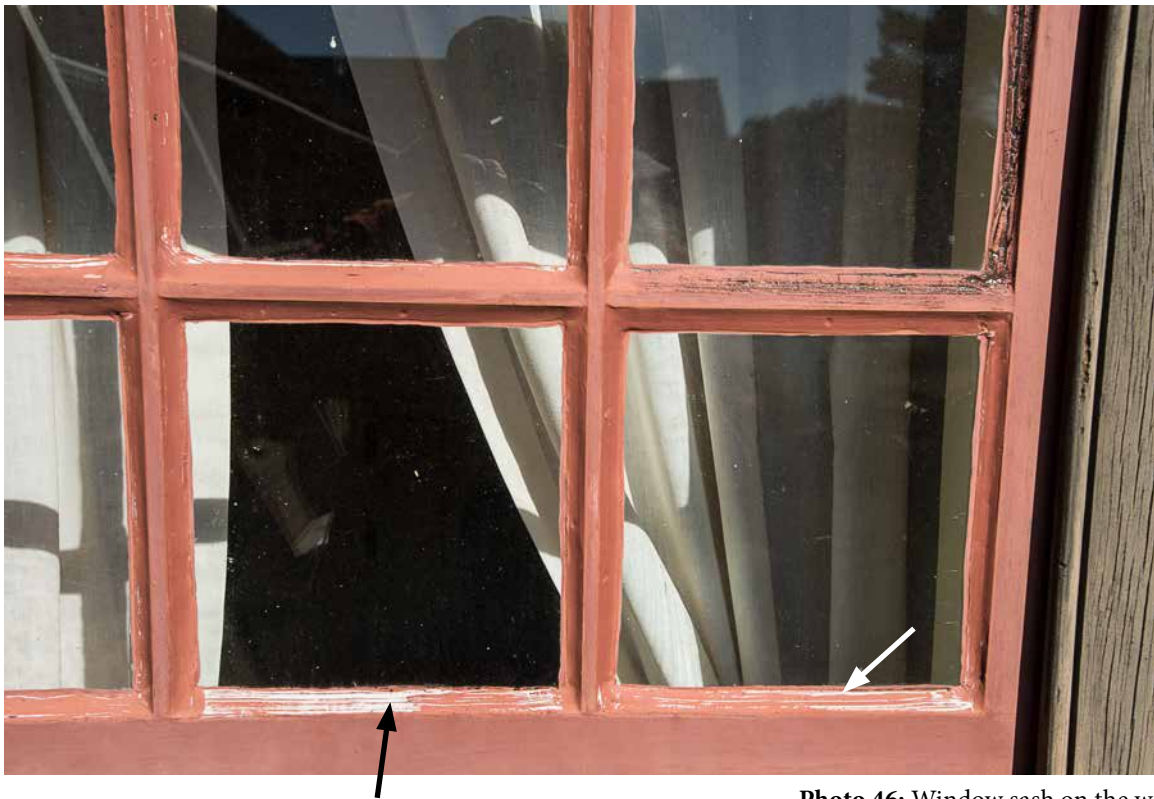
Photo 46: Window sash on the west side of the main block where the red finish paint has worn off exposing the white glazing putty. Without sound paint over it, the putty will dry out and crack and require expensive glazing replacement. The window sash should be repainted next year.

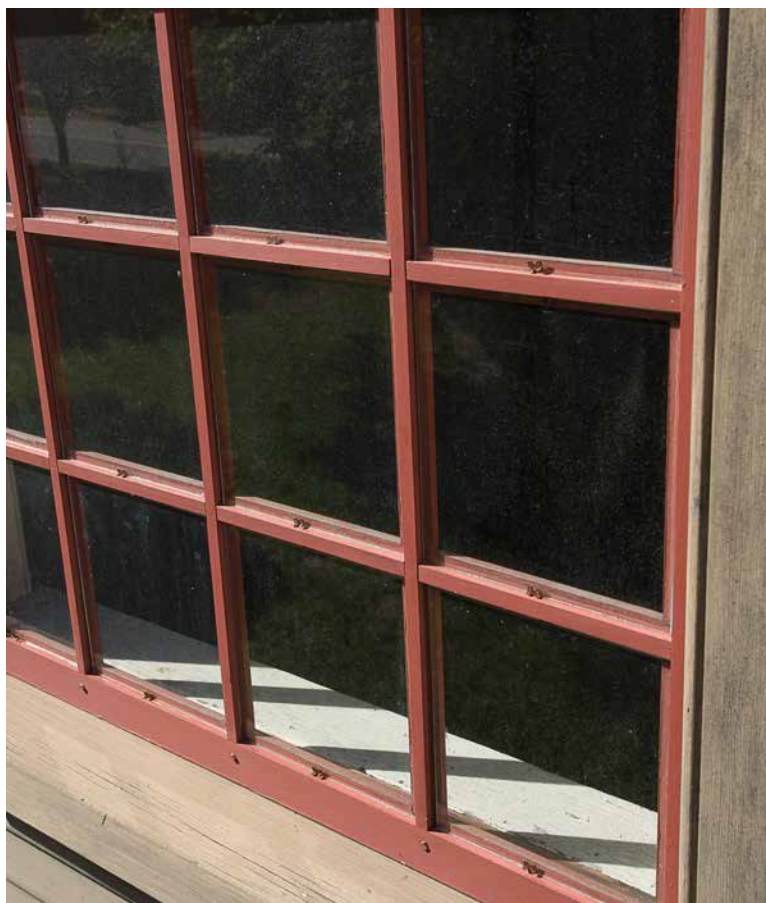
Photo 47: Window sash on the south side of the rear ell that never received exterior glazing putty. This window should be glazed next year.

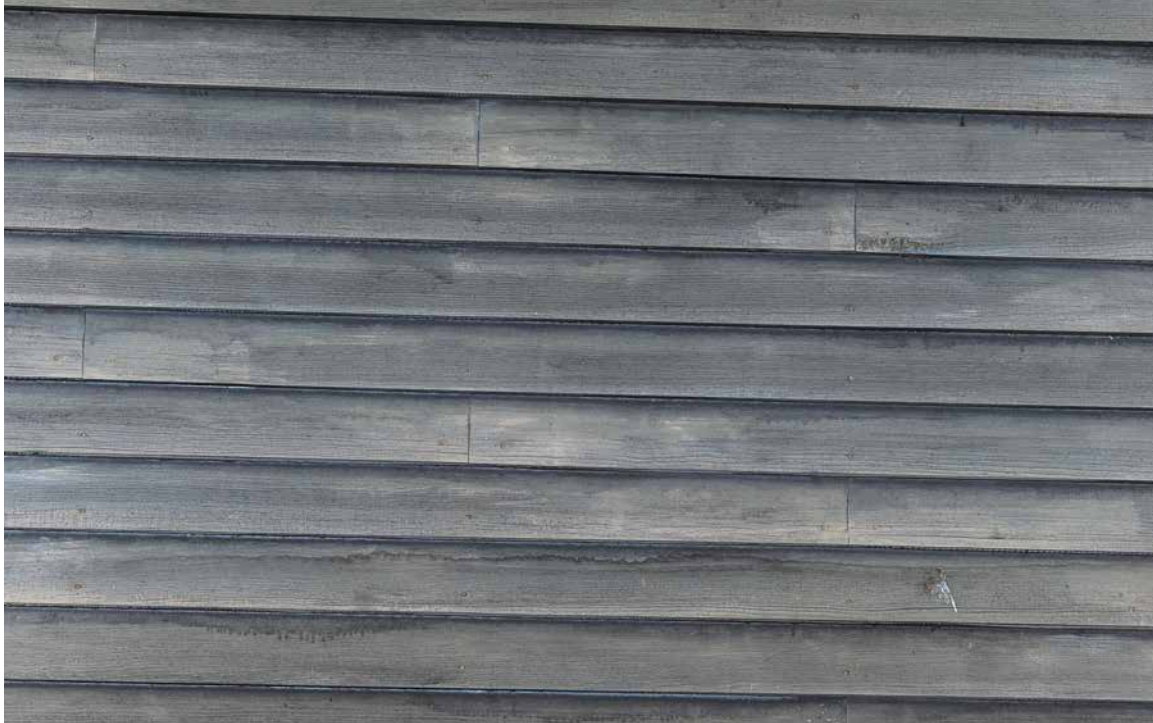
Photo 48: Clapboard siding where the paint (actually a semi-opaque stain) has weathered to become thin and blotchy, and no longer provides adequate protection to the wood surface against deterioration from ultra-violet light and moisture.

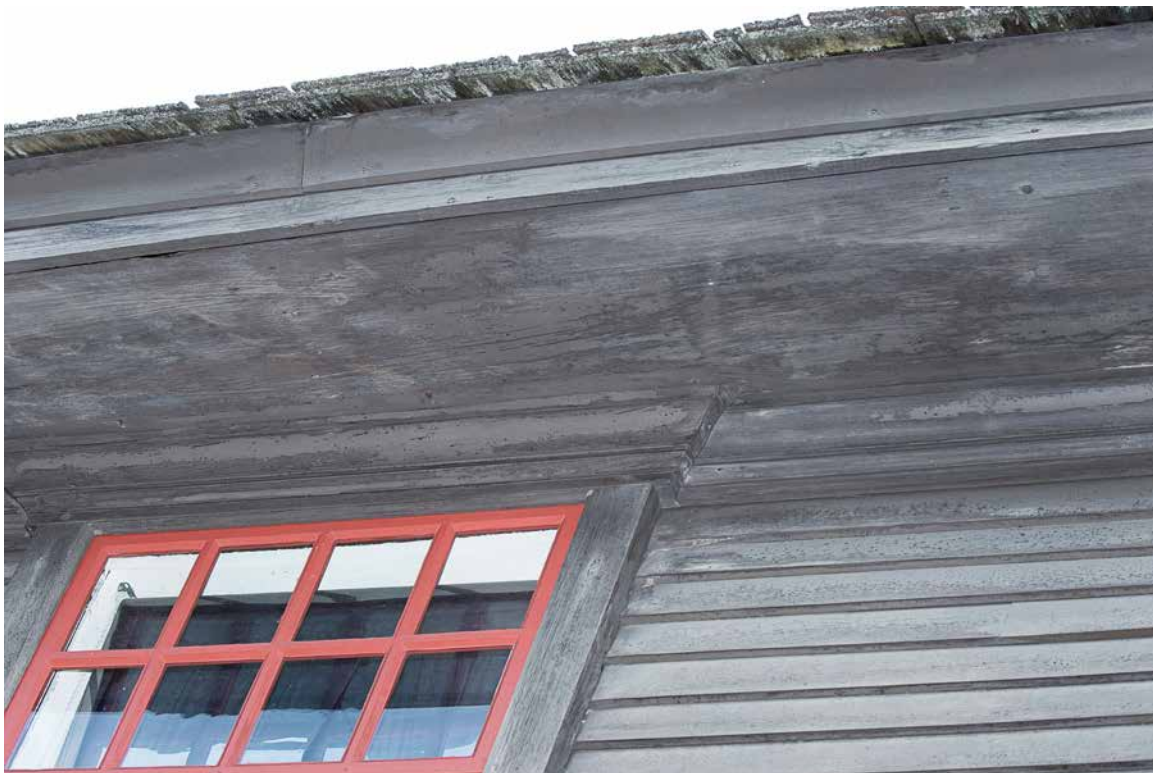
Photo 49: The underside of the front roof soffit is very blotchy indicating it needs to be repainted.

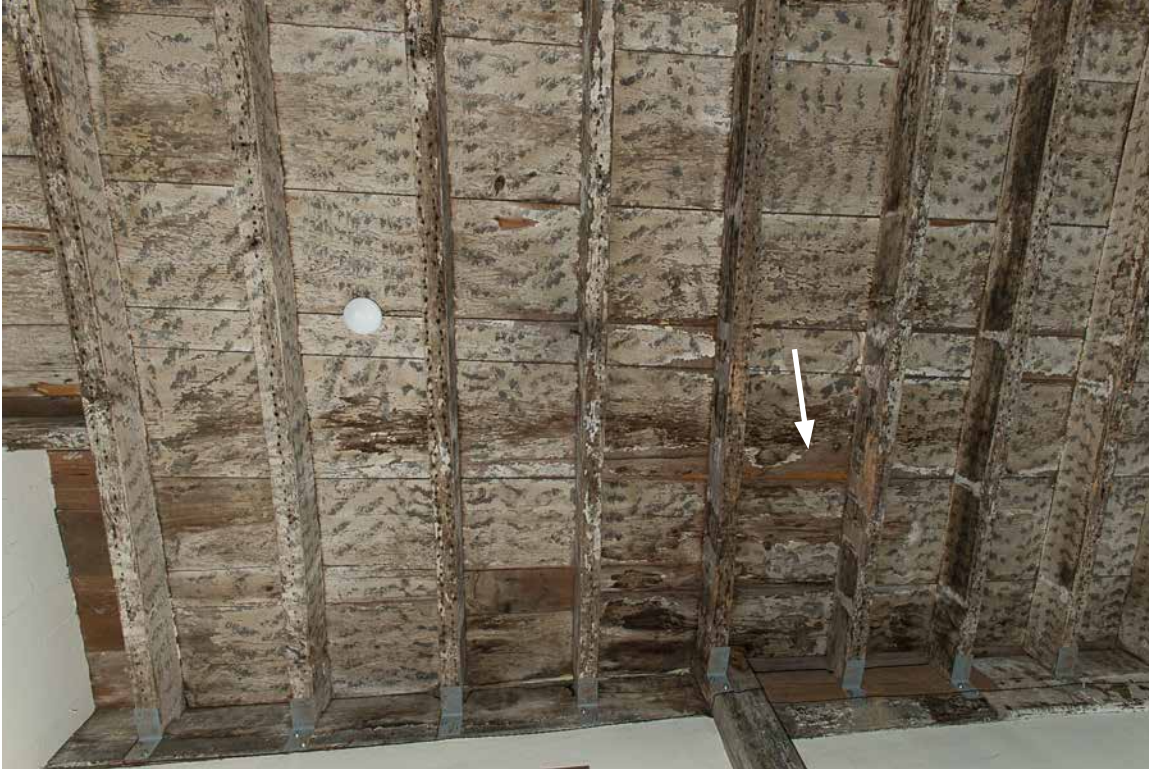
Photo 52: The condition of the decorative paint on the kitchen ceiling appears to be the same as it was in 2005 based on comparison with the photo below and others that were taken at that time.

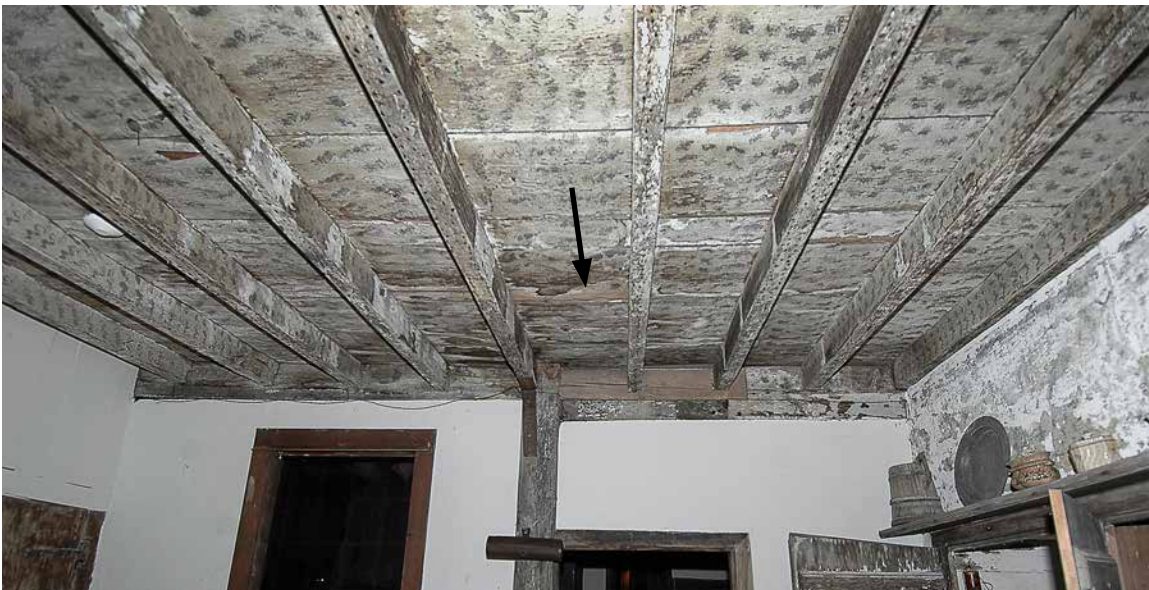
Photo 53: The the decorative paint on the kitchen ceiling in a 2005 photo. As an example, the arrow points to a large area of loss that is also marked with an arrow in the 2016 photo above.

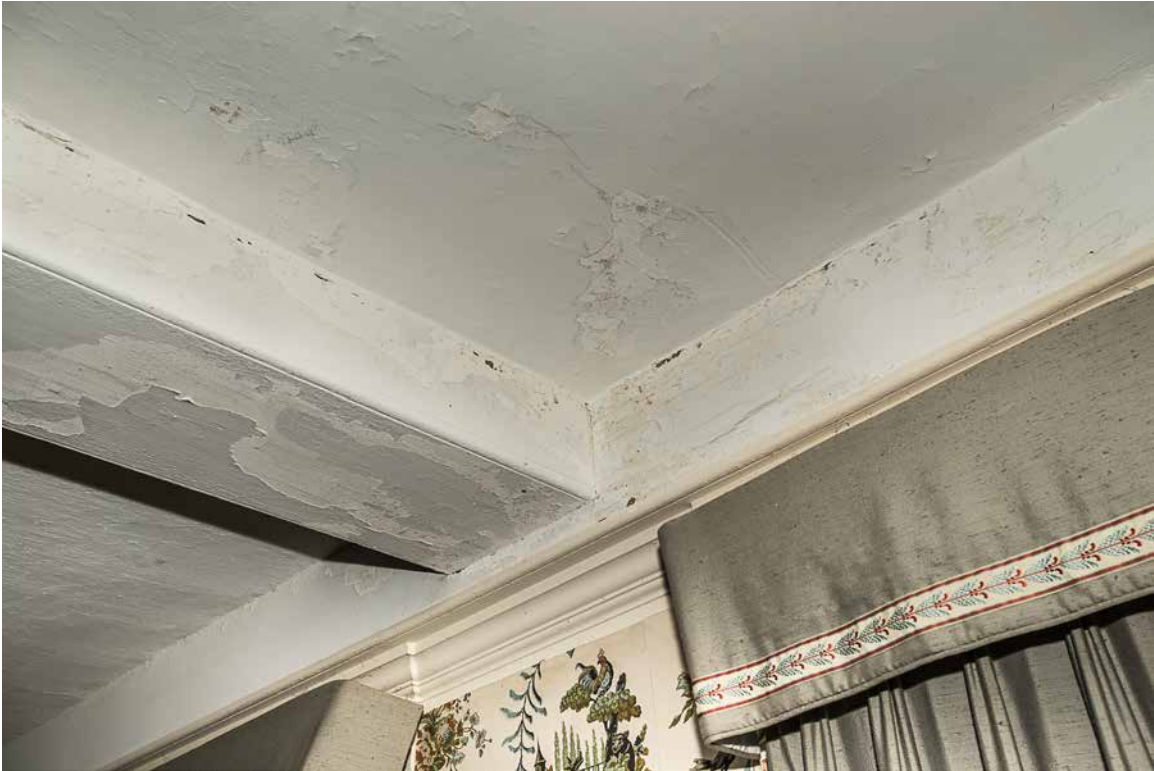
Photo 54: 2016 photograph showing substantial paint peeling on the beam casings and plaster ceiling. While there some paint peeling visible in the 2005 photos, the current extent of peeling is much worse. The primary cause is probably calcimine paint under the current modern paint.

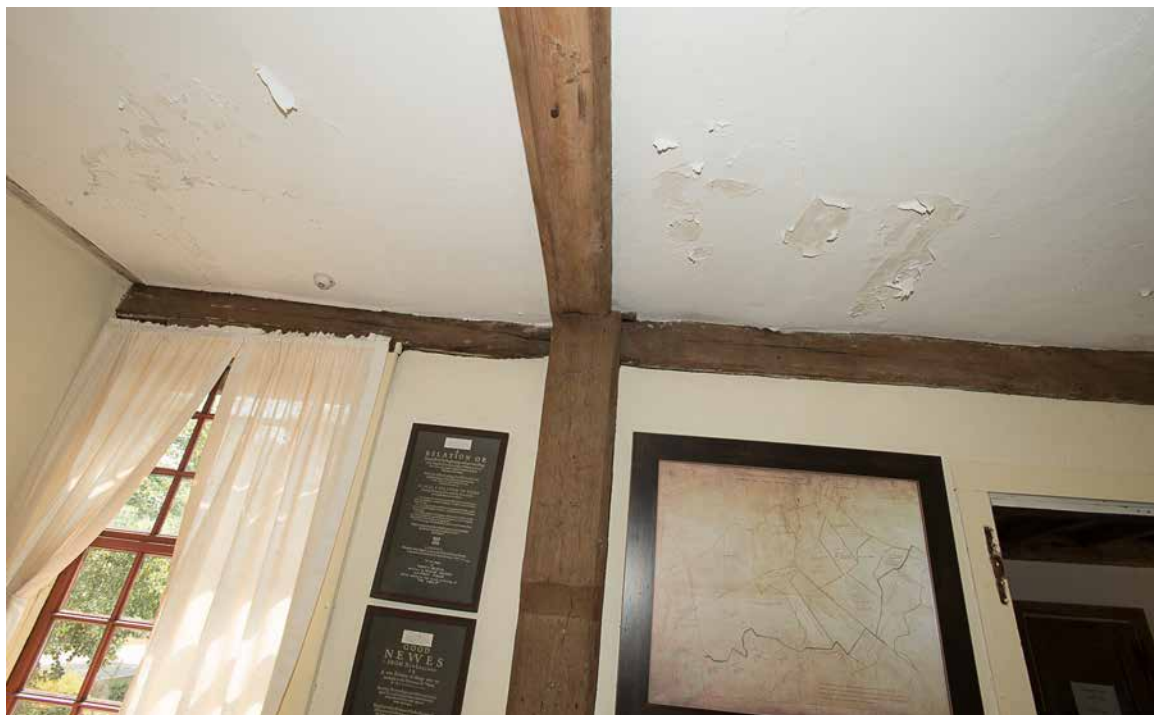
Photo 55: Another 2016 photograph showing substantial paint peeling on the beam casings and plaster ceiling of this room. Other than the parlor chamber, the most substantial peeling was occurring in the rear rooms of the main block.

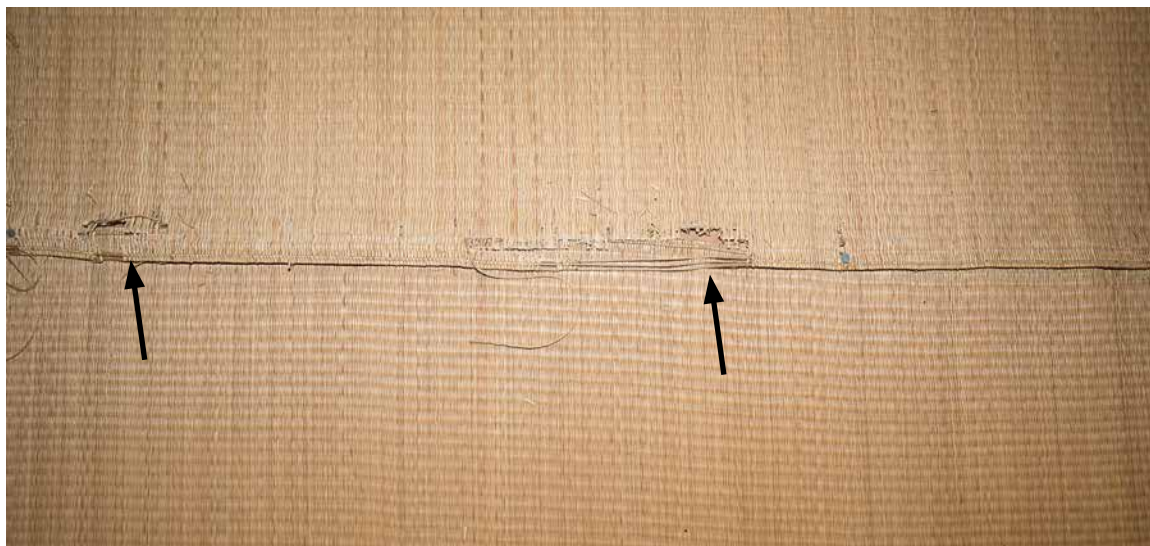
Photo 56: Wear on the edges of the straw matting (arrows) on the floor of the second floor kitchen chambers. This wear poses a tripping hazard for visitors. The matting should be redone with new matting similar to the existing. It was installed as a period appropriate floor treatment to cover the plywood sheets that were installed over the original floor boards to stiffen the floor and prevent loss of paint on the kitchen ceiling

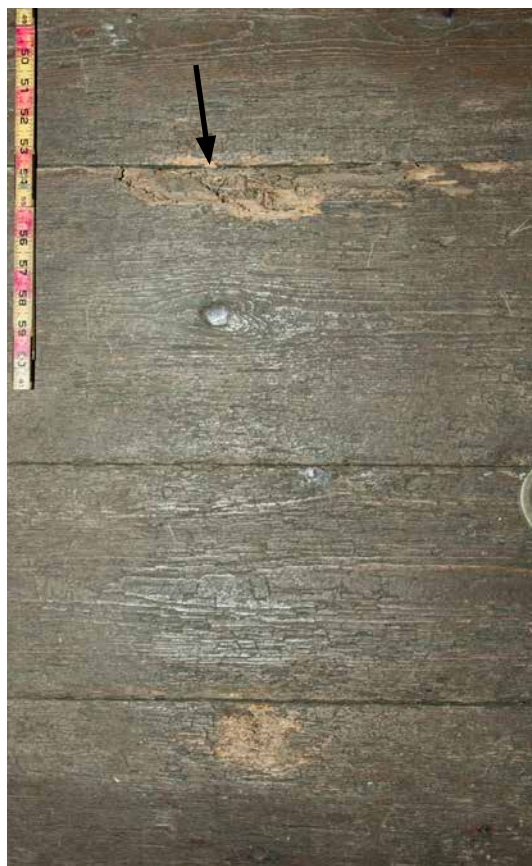
Photo 57: 2004 photo of damage to the surface of the floor boards in the hall (dining room) due to past insect damage. The arrow points to the area marked with an arrow in photo 58.
