ARCHITECTURAL CONDITIONS ASSESSMENT

December 31, 2016

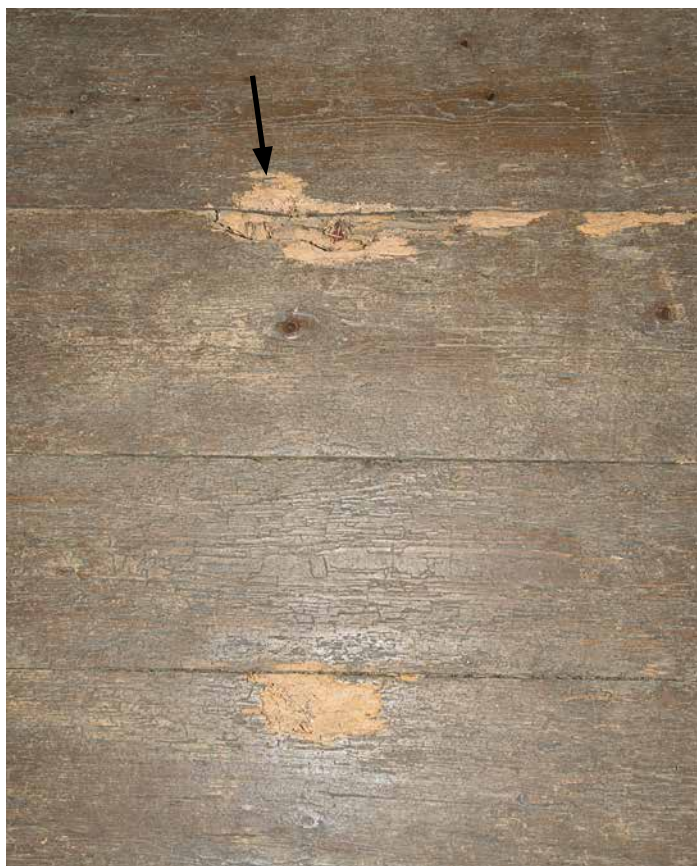
Photo 58: 2016 photo of the same area of damage to the surface of the floor boards in the hall shown in photo 57. The extent of damage has slightly increased since 2005, but is still quite limited.

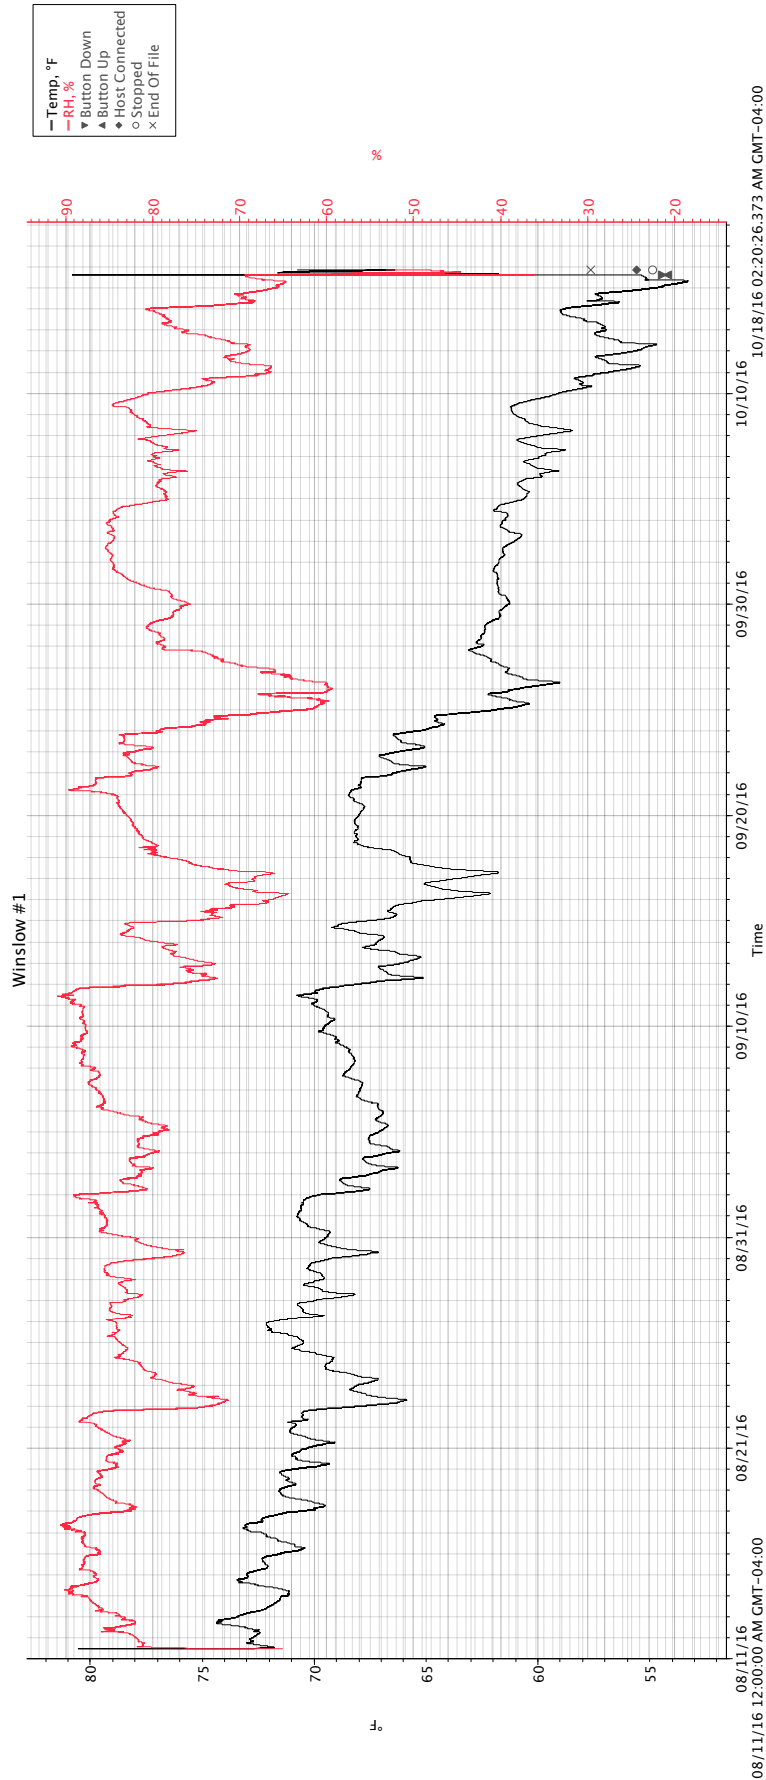
Figure 1: Graph of temperature and humidity in the main house cellar recorded from August 11, 2016 to October 17, 2016. The red graph is the relative humidity (RH) with the RH scale on the right side in red. The black graph is the temperature with its scale on the left side in black. Readings were recorded every 10 minutes throughout the period.

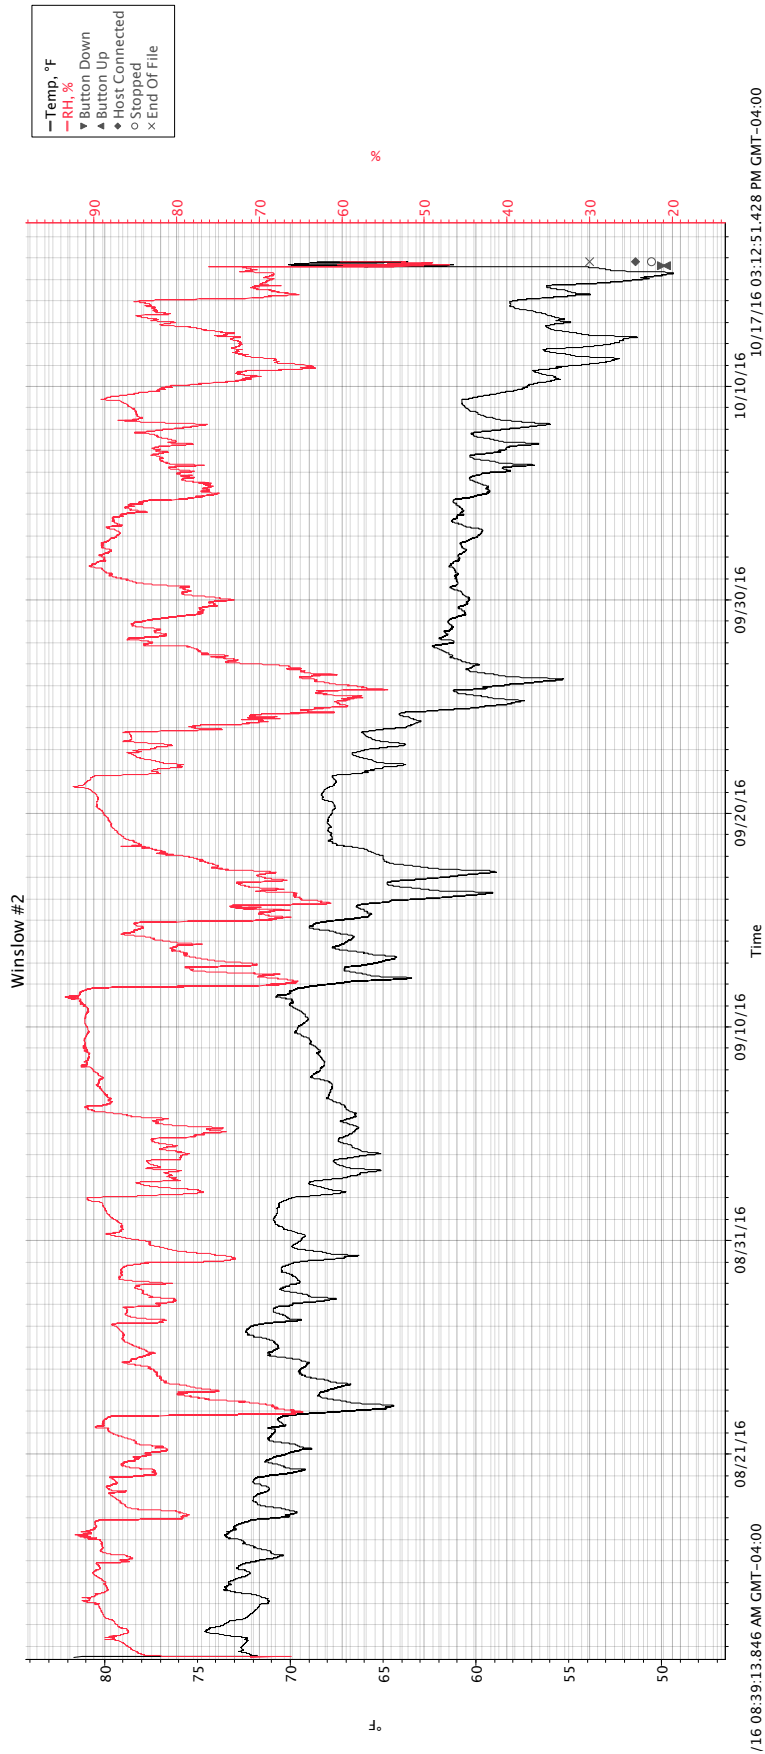
Figure 2: Graph of temperature and humidity in the rear ell cellar recorded from August 11, 2016 to October 17, 2016. The red graph is the relative humidity (RH) with the RH scale on the right side in red. The black graph is the temperature with its scale on the left side in black. Readings were recorded every 10 minutes throughout the period.

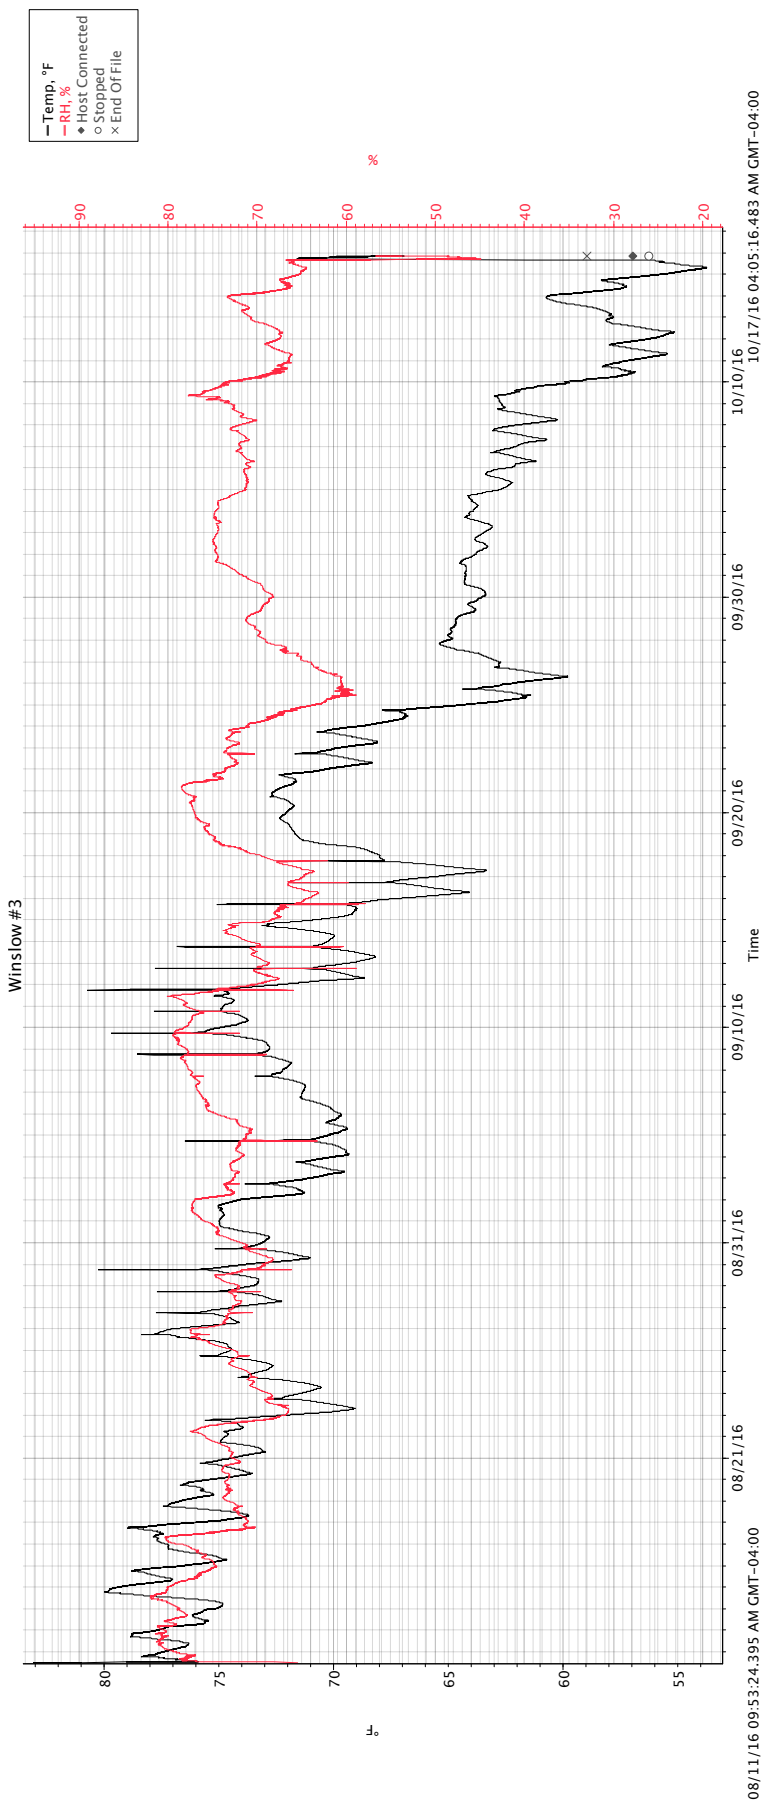
Figure 2: Graph of temperature and humidity in the diary recorded from August 11, 2016 to October 17, 2016. The red graph is the relative humidity (RH) with the RH scale on the right side in red. The black graph is the temperature with its scale on the left side in black. Readings were recorded every 10 minutes throughout the period. While a dehumidifier was running in this space through most of the period, it is believed that it was not functioning properly and was therefore not effective.

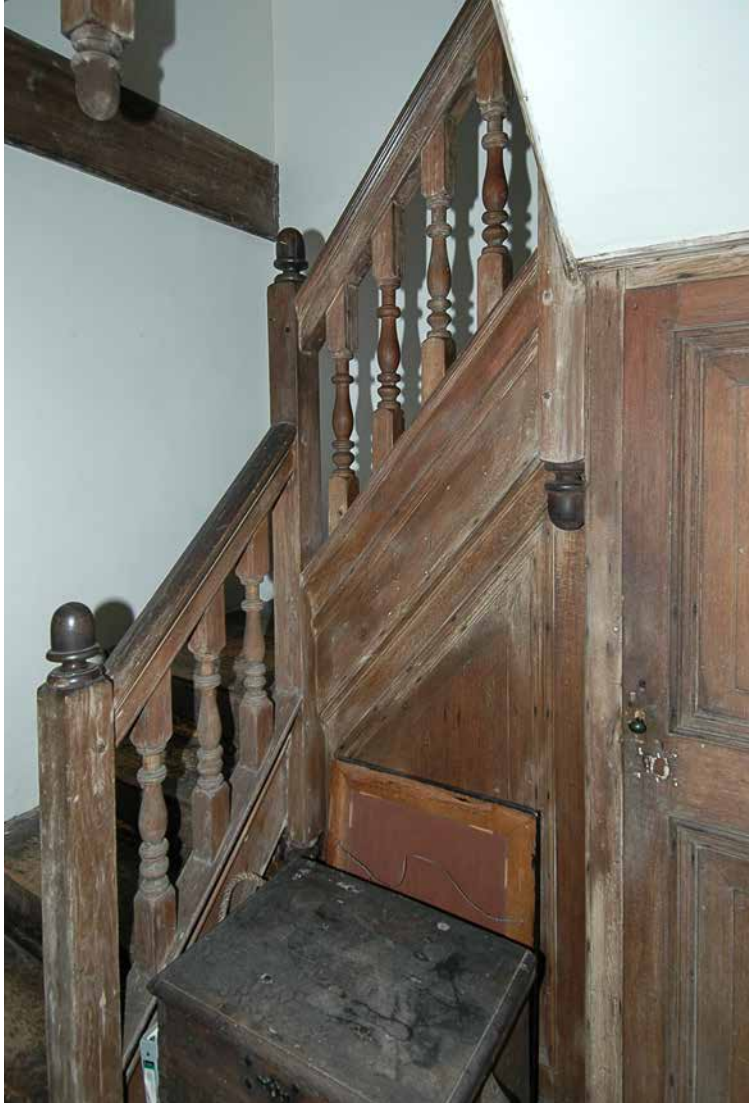
Photo 59: Main stair and adjacent woodwork at the Winslow house showing bold turned balusters and bolection moldings on the paneling and closet door that are typical of late first period detailing.

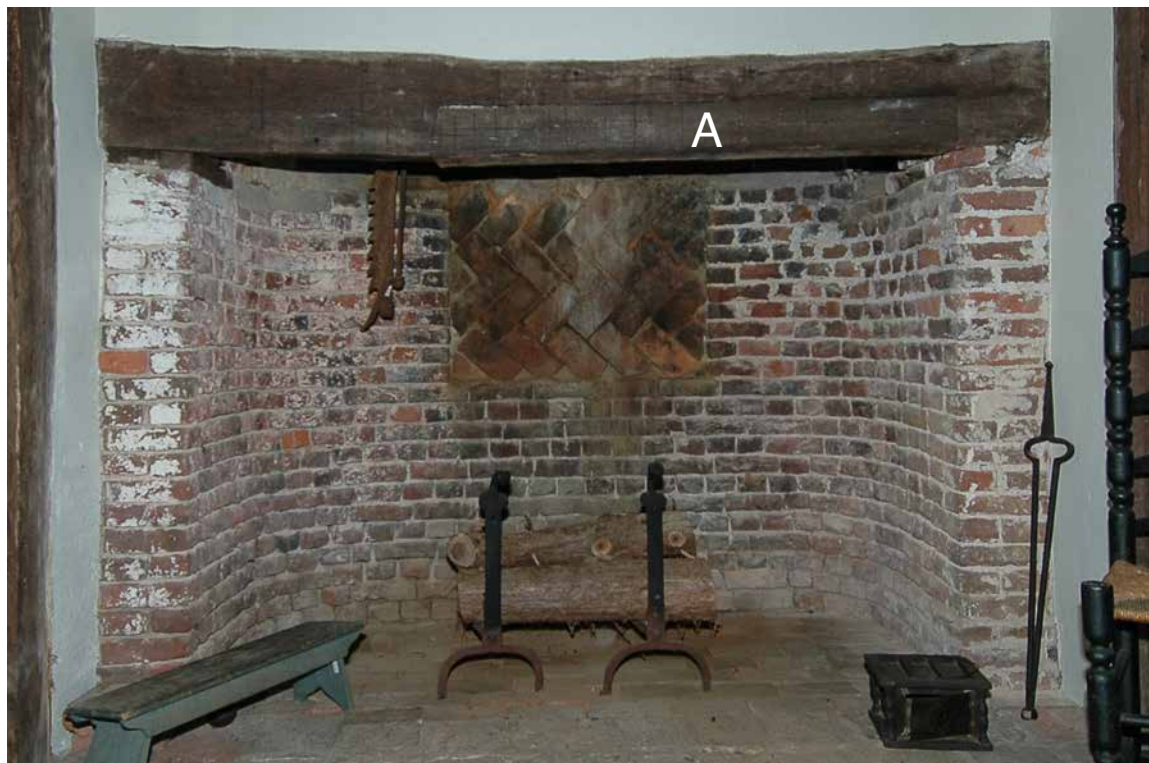
Photo 68: The current appearance of the hall (dining room) fireplace is the result of the 1920 restoration that removed later masonry infill that had reduced the fireplace to a smaller size to fit the wall of paneling that had been installed in the second half of the 18th century. Although there are no records indicating how much of the brickwork was found intact, its size and basic form with rounded rear corners is probably accurate. That the herringbone panel is laid up in clay suggests it is original. The lintel with its Dutchman infill (A) that corresponds to the location of the later fireplace is also original.

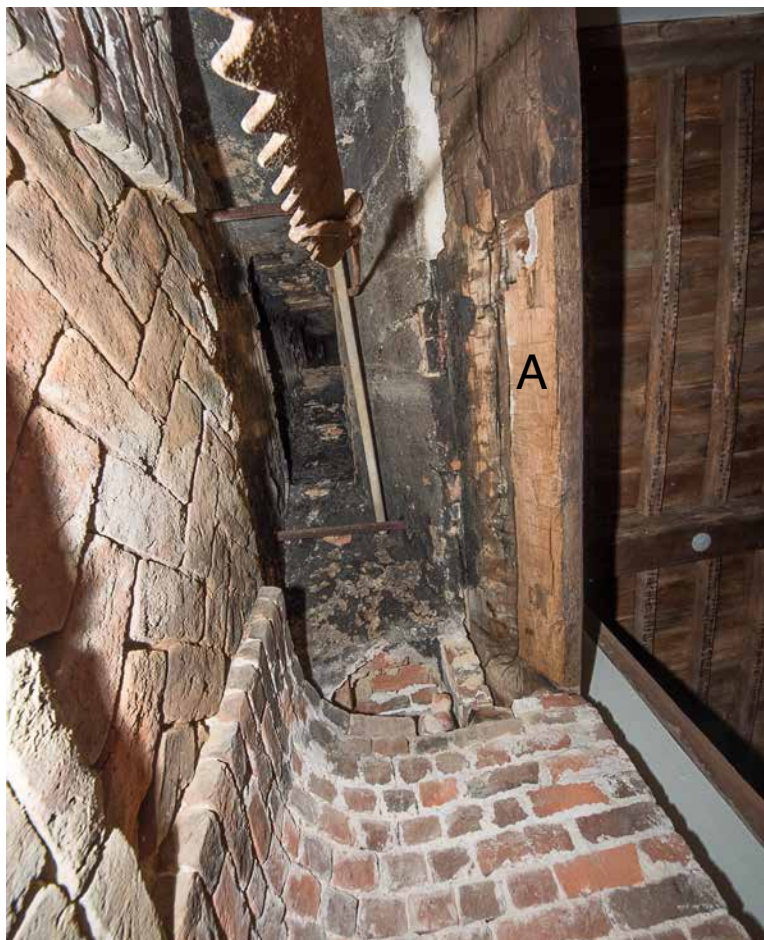
Photo 69: Looking up the throat of the fireplace, the char across the full width of the current opening indicates the original width was as restored. The 1920 Dutchman is again marked "A".

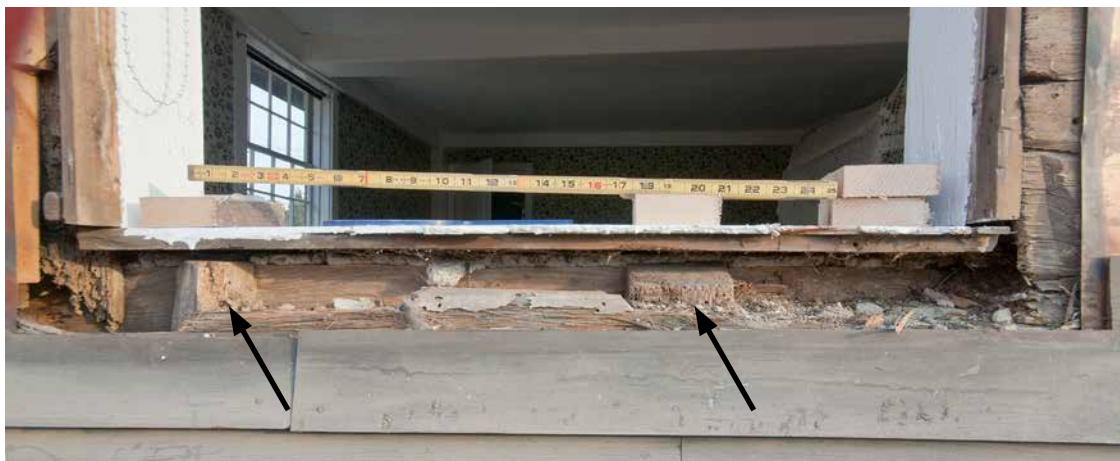
Photo 78: West facade parlor chamber window sill showing evidence that the current two windows in the west wall are not original. They were probably installed when the room was remodeled in the mid 18th century to replace a single window in the center of the wall. The evidence is the two wall studs marked with the arrows that were cut off to install the window. This photo and those below were taken in 2006.

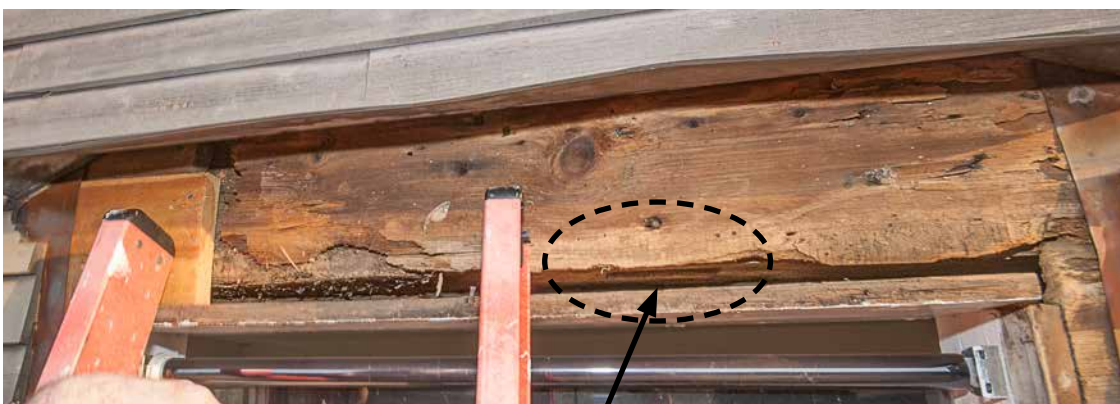
Photo 79: West facade parlor chamber window head showing empty mortise in the girt that originally housed the tenon of the stud marked in photo 78. The stud was partially removed to install the window. Presumably the two first floor windows in the parlor directly below were also installed at the same time. The dashed circle marks the area shown in photo 83 below.

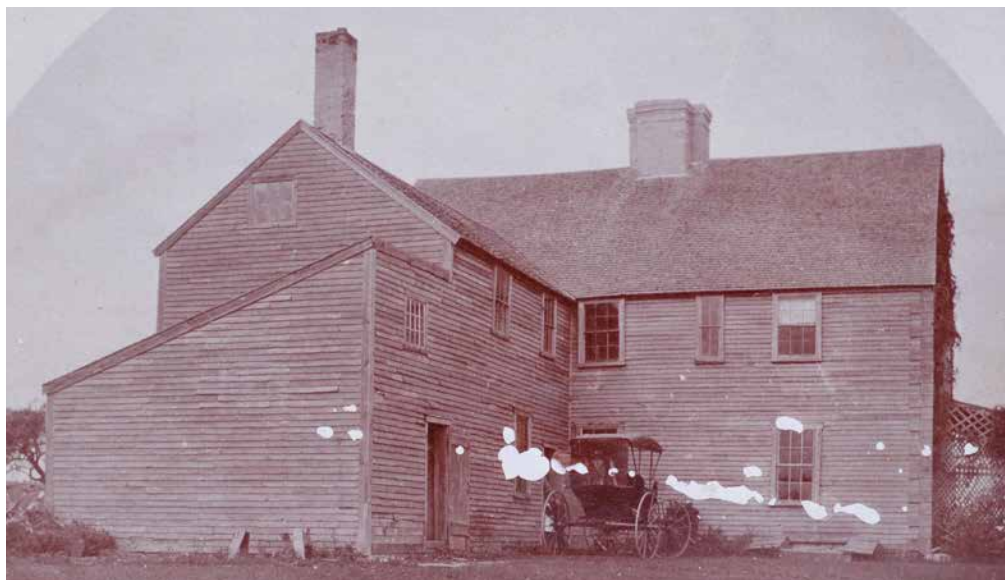
Photo 81: Probably the earliest photograph of house, as its round format suggests a date of the 1860s or 70s. The house has 6/6 window sash that likely date to the first half of the 19th century. Its clapboards are in relatively good condition, although the ell is starting to get a little ragged. *Photo from Winslow House Archives.*

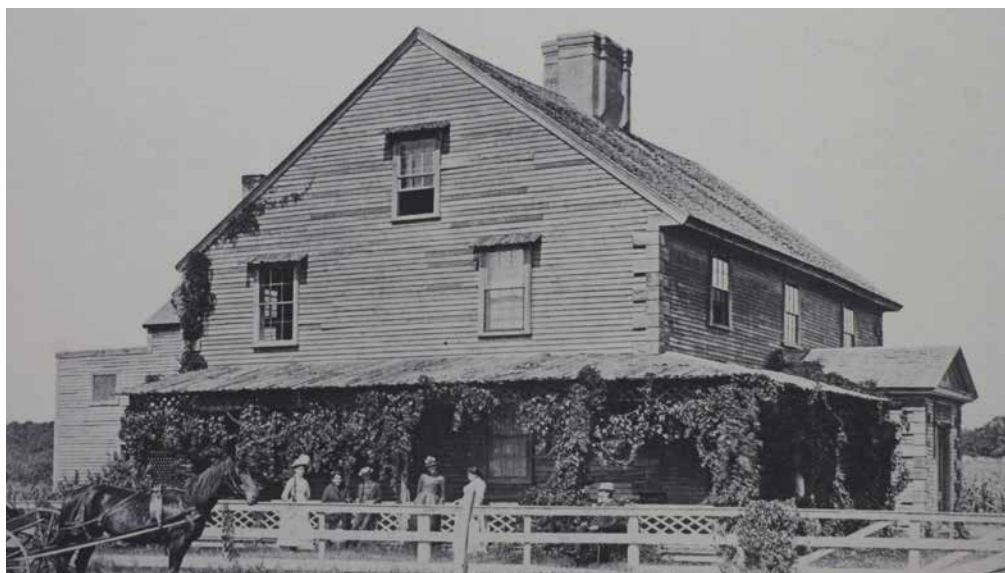
Photo 82: Another early photo, perhaps from the 1870s or 80s based on the dress. This shows the added first floor porch and hoods over the south side windows. The porch is also present in photo 81. *Photo courtesy of Historic New England.*

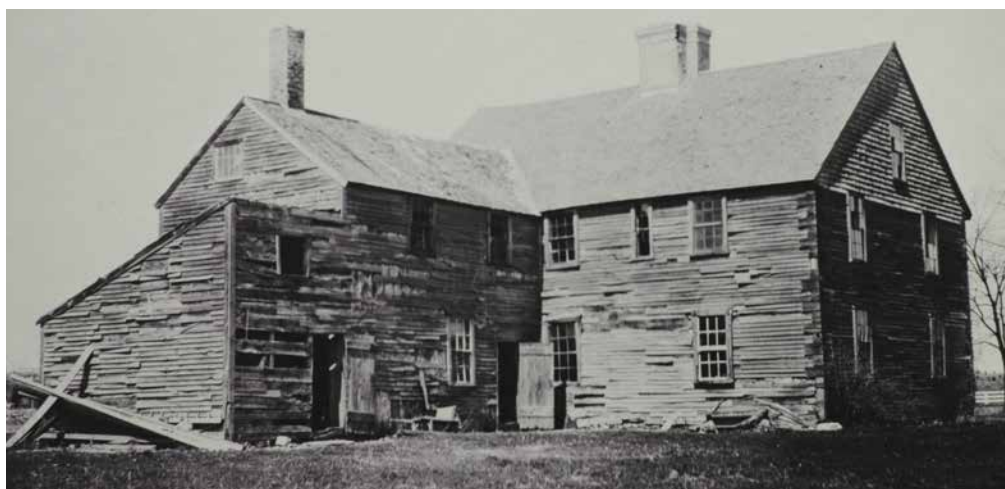
Photo 83: Photo dated 1916 showing the very rundown condition of the house before it was acquired for restoration in 1919. The hoods over the south facade window and the porch have disappeared, and the attic gable has been shingled. *Photo courtesy of Historic New England.*

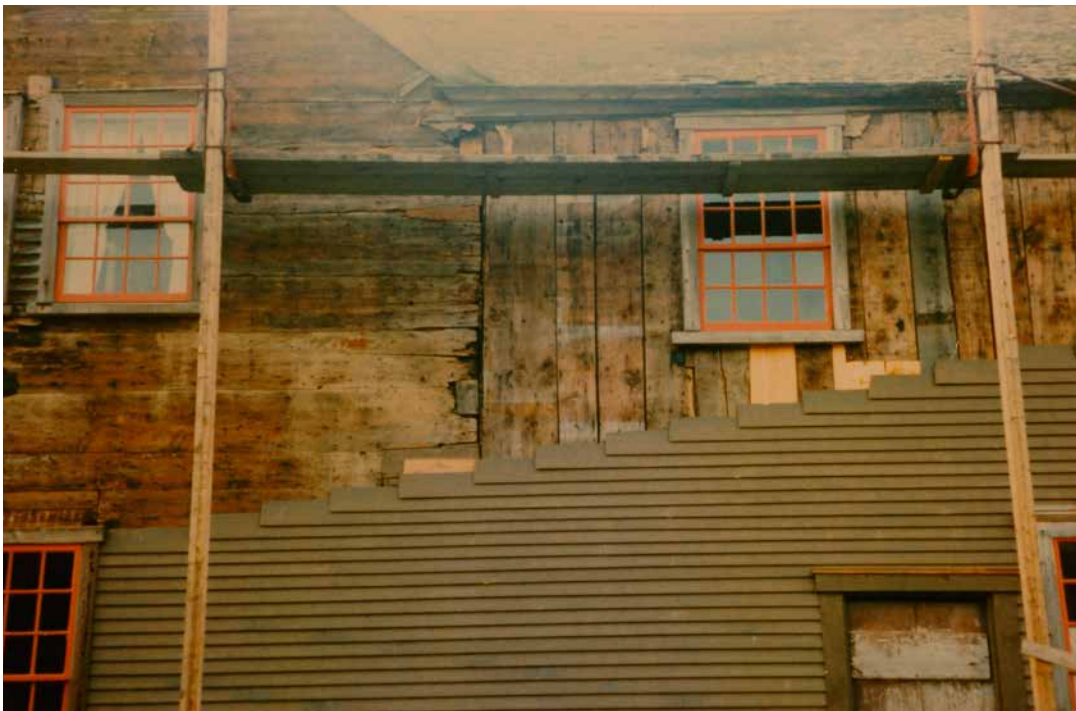
Photo 84: Junction of the north sides of the main block and the rear ell during the installation of new clapboards in the 1990s. The sheathing on the main house runs horizontally indicating it is of stud frame construction. The sheathing on the ell is vertical indicating it is of plank frame construction. Using a different framing style makes the ell unlikely to have been built as an original part of the house.
